Vibrations from the Front Axle

Part 1 of GARP, The Great Axle Reconstruction Project

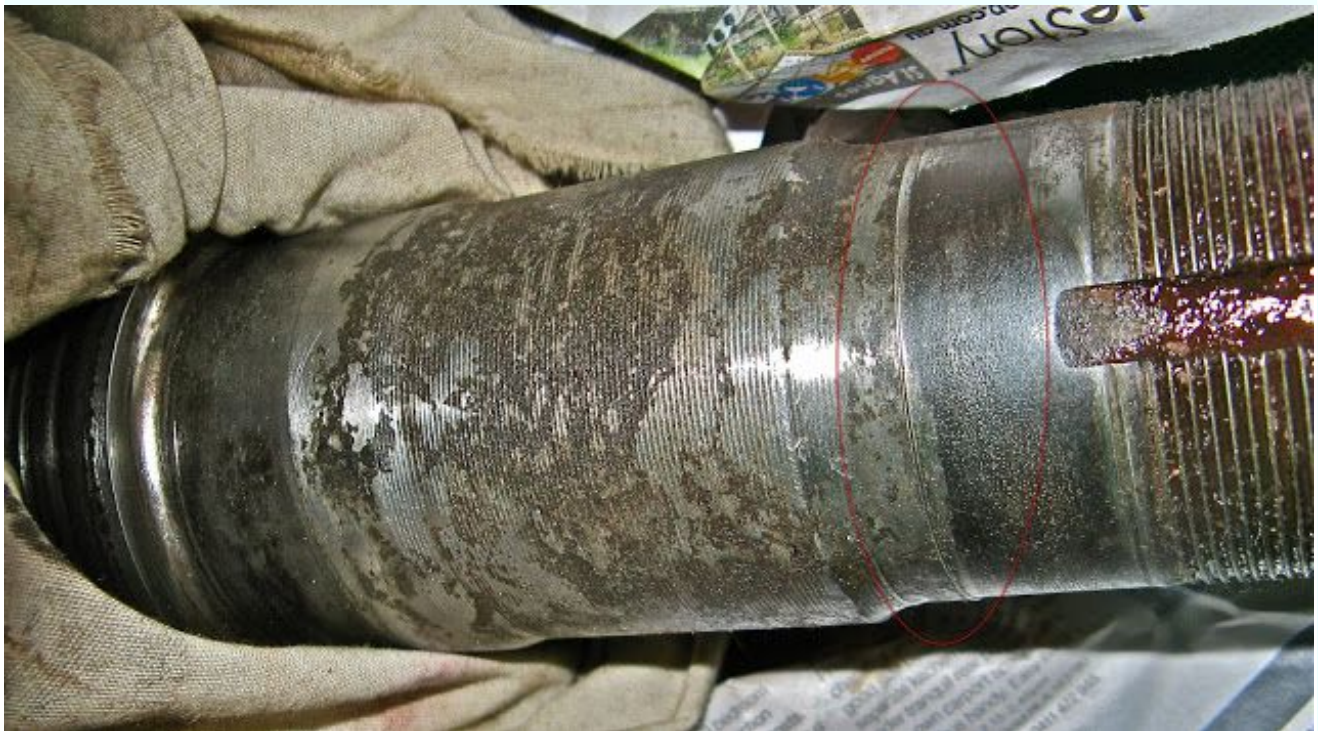
Pic 1. The groove and ridge ringed on the spindle shaft.

It only took an hour or so to get to the heart of the problem, the outer bearing shell had indeed been rotating on the spindle and worn a groove (about 0.5 mm deep), so that the bearing was a fairly loose fit on the shaft. A ridge had also developed which prevented it from sliding freely, and this would affect the bearing pre-load adjustment as well. See ringed area on Pic 1.

So I investigated a repair process. I found a company in Adelaide (Adelaide Grinding) that would deposit a coating of metal on the shaft (by replating or metal spraying) and then regrind the bearing surfaces to their original dimensions. Since I wanted to do this only once, I also had the inner bearing surface treated at the same time, even though it wasn't as badly worn. Even better, the total cost was less than a quarter of the new spindle price.

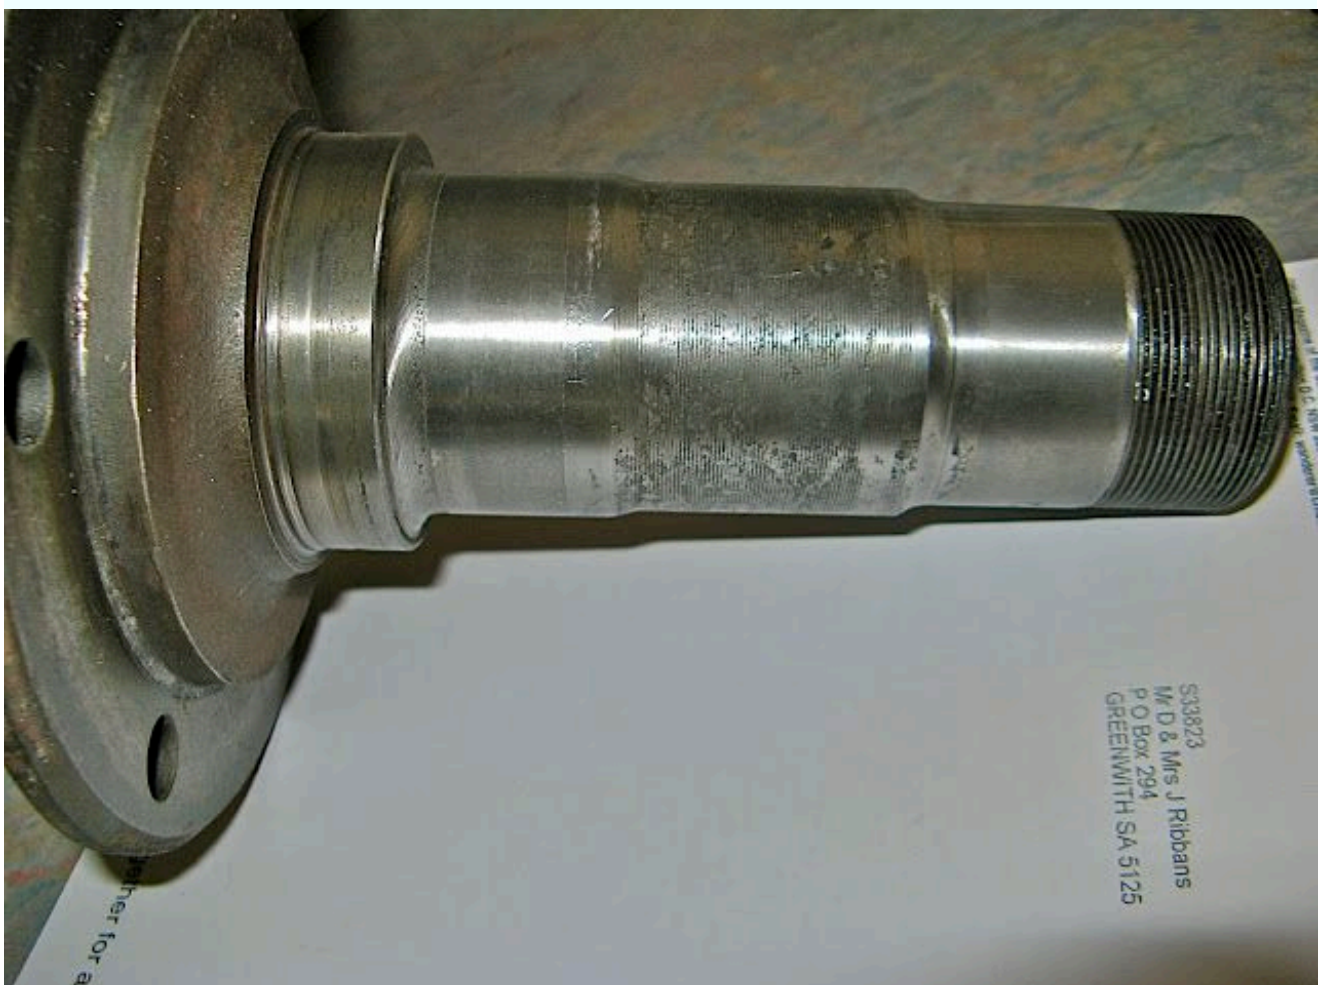
Pic 2. The repaired spindle. Bearings are a good tight slide fit on the reground shafts.

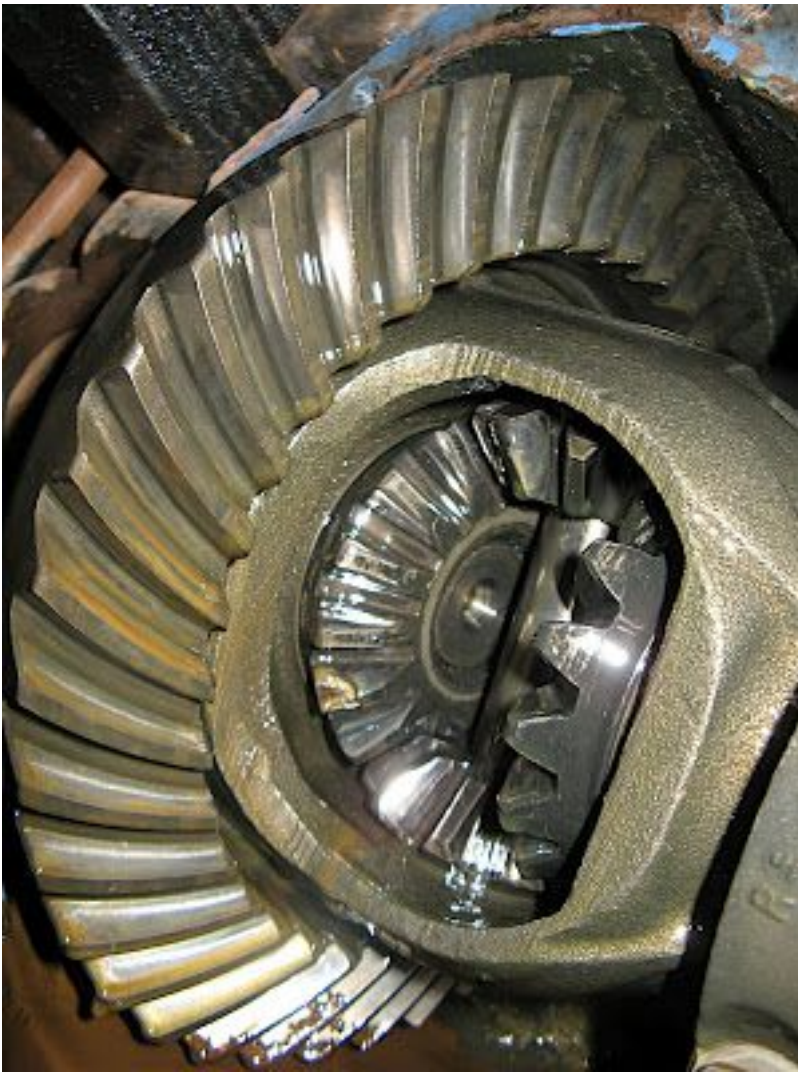
So I loosened the diff cover bolts to let the oil out (for there are no drain plugs on these axles) and heard a "clink" as something dropped into the tray. Rather than dirty my fingers, I got my magnetic wand out and stirred it around in the dirty oil. When I removed it there was part of a gear tooth attached to the end.

My heart sank as I knew what that would mean, and sure enough, when I removed the cover and turned the inner gears around there was one with part of its tooth missing.

Pic 3. Toothache in the differential.

So, buoyed with the negligible enthusiasm which stems from having reluctantly removed the diff, I went on the hunt for replacement gears, and once again in the US they are easy to come by, but not so easy in Oz. They are available from a few auto parts companies specialising in American vehicles, (eg [here](#) and [here](#)) but to be sure I got Oka compatible components, I acquired a second hand set from Paul Nott at [East Coast Oka](#) in Melbourne (which turned out to be a lot less worn than my original set). With some replacement oil seals on the way from Oka in Perth I am now able to start GARP, the *Great Axle Reconstruction Project*.
