## ELECTRICS T.I. BULLETIN INDEX

## ECU DIAGNOSTICS INSTRUCTIONS

**PRODUCTS AFFECTED: Powershift Transmissions with 36-Way ECU**

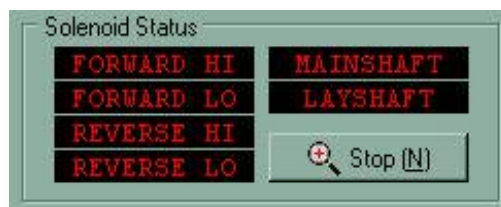
3.15. Faulty solenoids or connections will be shown highlighted. In the example below we can see that all the solenoids are faulty. (This would mean that the gearbox harness is not connected.)

3.16. The solenoid name will be seen to become un-highlighted as the fault is cured

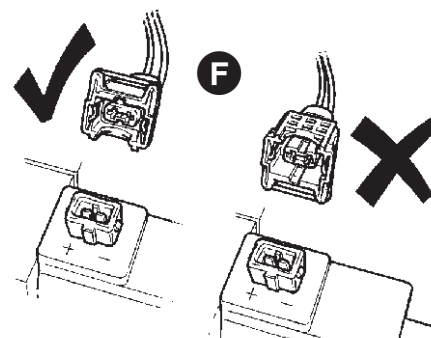
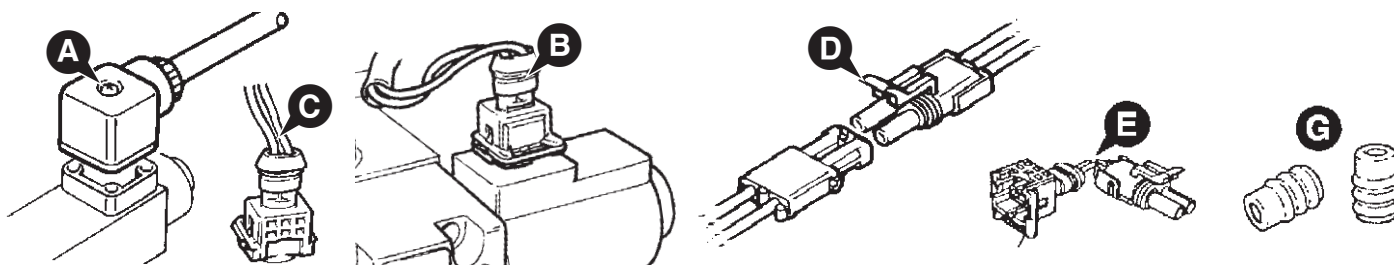
Replacement transmission solenoids with connectors type **A** have been superseded to the current connector type **B**. To change this type of connector the machine harness will have to be modified by splicing on a new connector **C**. Refer to JCB T.I. 2/174 (C45 N. Am.) March 1997 and JCB General Bulletin 020 (C30 N. Am.) Feb. 93.

**IMPORTANT NOTE:** All later solenoids have diodes built into the coils. The diodes will be damaged if the coil is connected with reverse polarity causing the coil to fail and the fuse to blow.

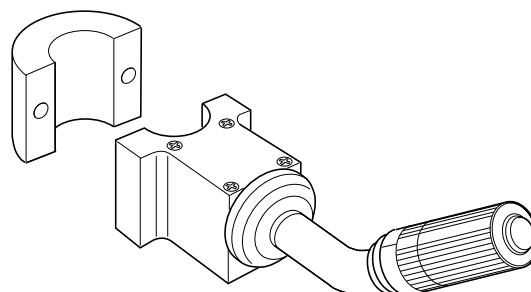
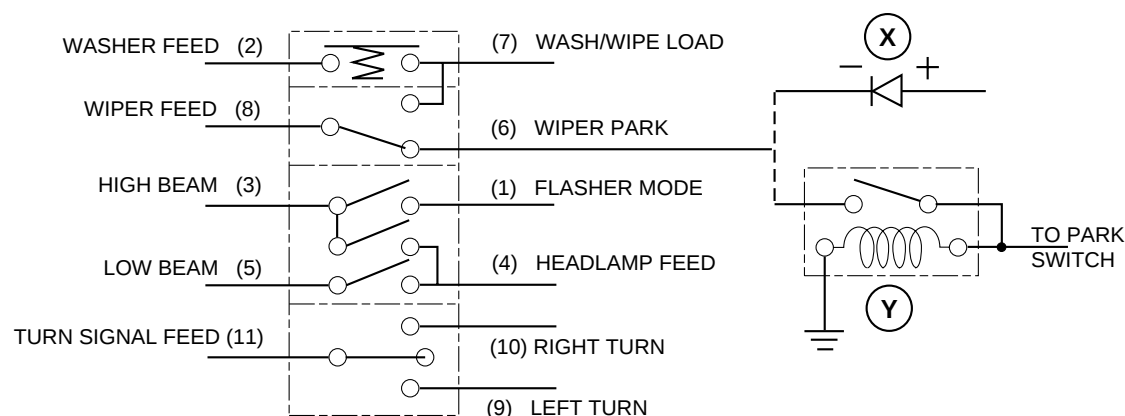
Investigation into reports of the wiper fuse failing when the wiper control is operated slowly has identified that when the wiper park circuit is grounded to earth and not relay controlled as shown on the illustration at **Y**, to prevent a short circuit in the lever, a diode should be installed into the wiper circuit at **X**. This is common electrical practice and is not a 'defect' in the lever.

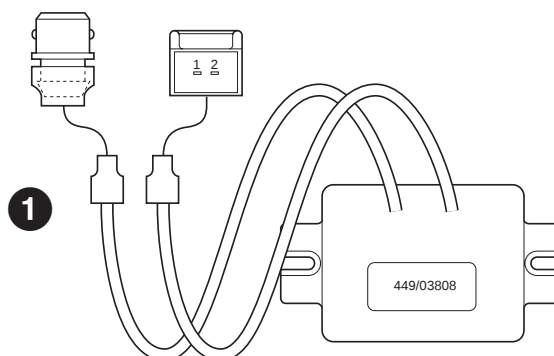
**The momentary illumination of the lamp should not be interpreted as a transmission fault** and can be attributed to the sensitivity of the pressure switch, providing the light does not illuminate when no gear selection is made.

The sensitivity can cause concern to some operators, and for this reason ITL have made available a signal delay timer unit **1**. The unit delays the signal from the pressure sensor for 1.5 seconds as the clutch packs fill with oil and the pressure momentarily drops.
