Free Wheeling Hub Maintenance

Many Oka owners have AVM freewheeling hubs and several (including me) have had on-going problems with them.

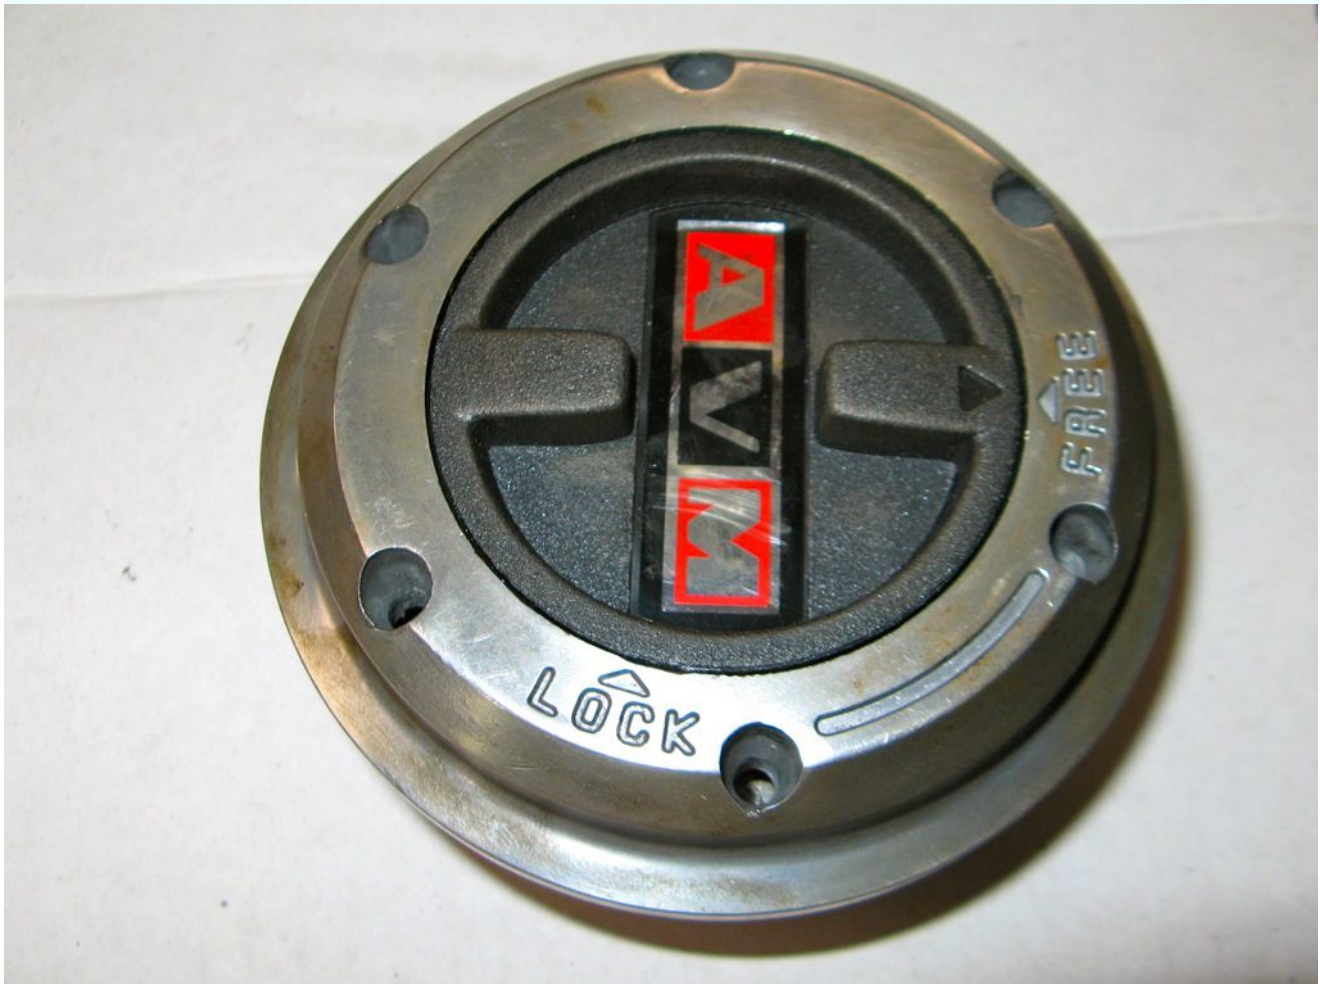
The AVM Model 439 Free Wheeling Hub for 30 spline shafts

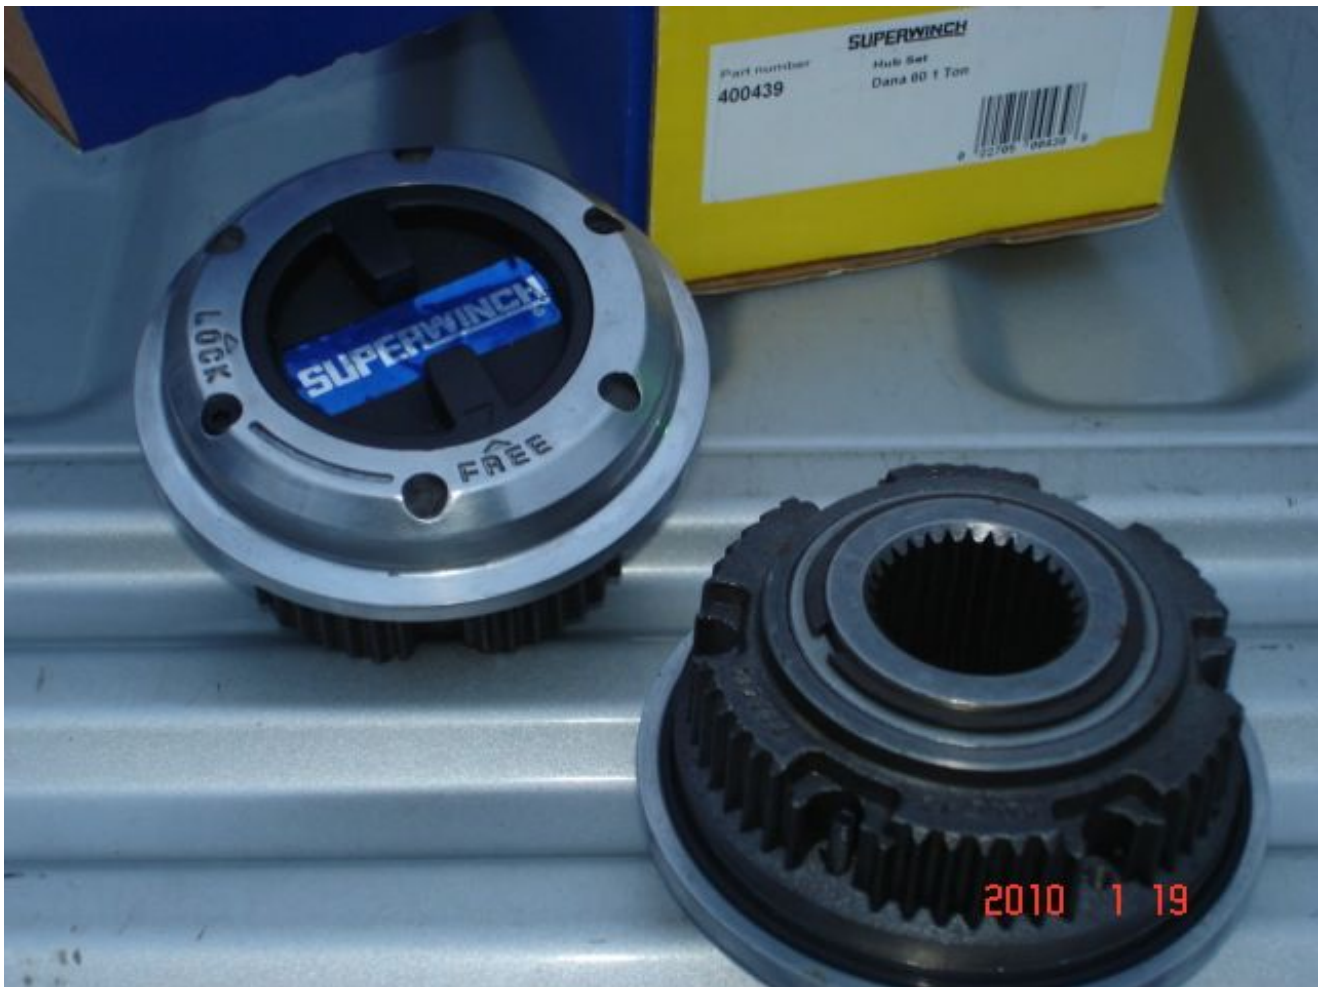
If you have SuperWinch Free Wheeling Hubs like this, you will probably also have the same problems. They look like rebadged AVM's and I know of one which is stamped with the same casting number, 439. The SuperWinch part number is 400439.

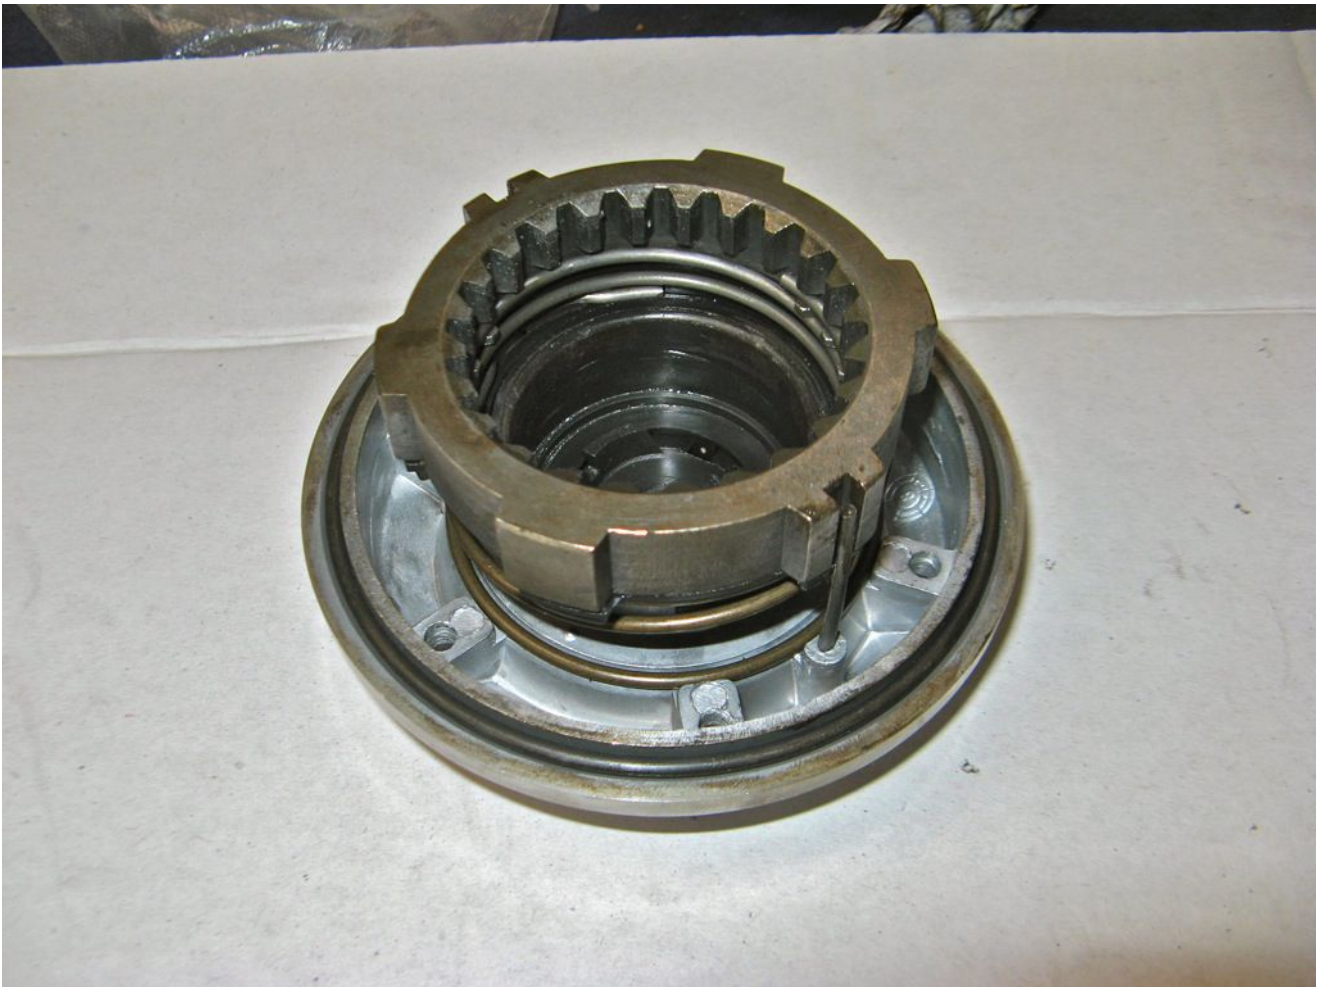
The locking ring and spring behind the outer assembly shown in the Lock (expanded) position

The locking ring is attached via a spiral spring to a plastic ring with 3 tangs on it to engage in the grooved cylinder and its alignment is maintained by 2 thin roll pins inserted into the aluminium frame.

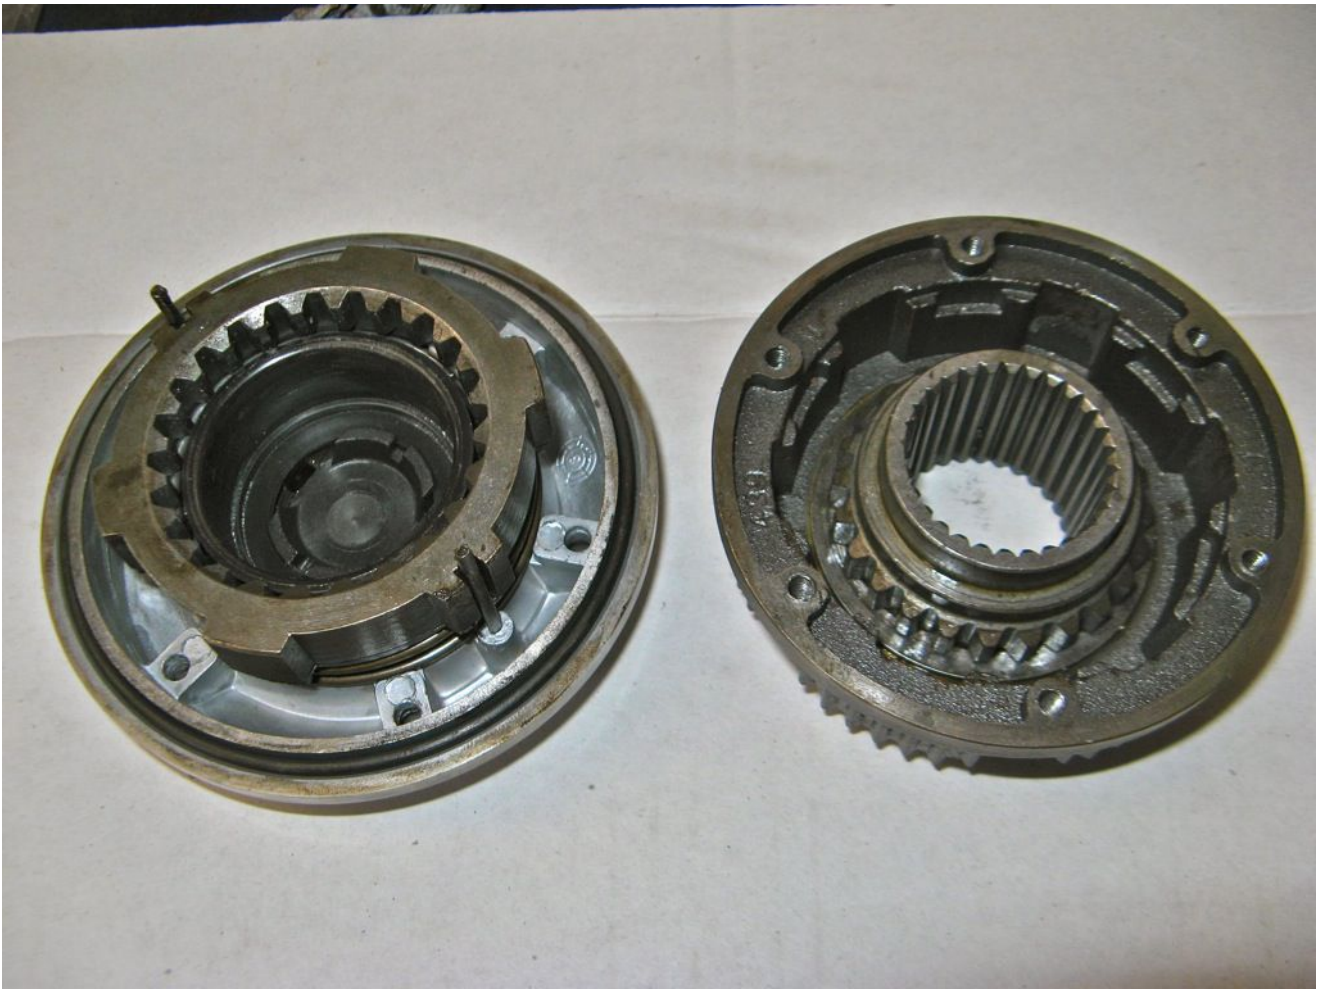
The rectangular cams and gear teeth on the locking ring on the outer assembly on the left (shown in the retracted Free position) engage with the inner gear assembly on the right to lock the hub

When the lever is moved to the Lock position, the cylinder is rotated by the control lever and the tangs on the locking ring slide down the grooves. The spring expands pushing the locking ring into the inner assembly, locking the splined central shaft to the outer hub by engaging the gear teeth and the ring of 6 rectangular cams.

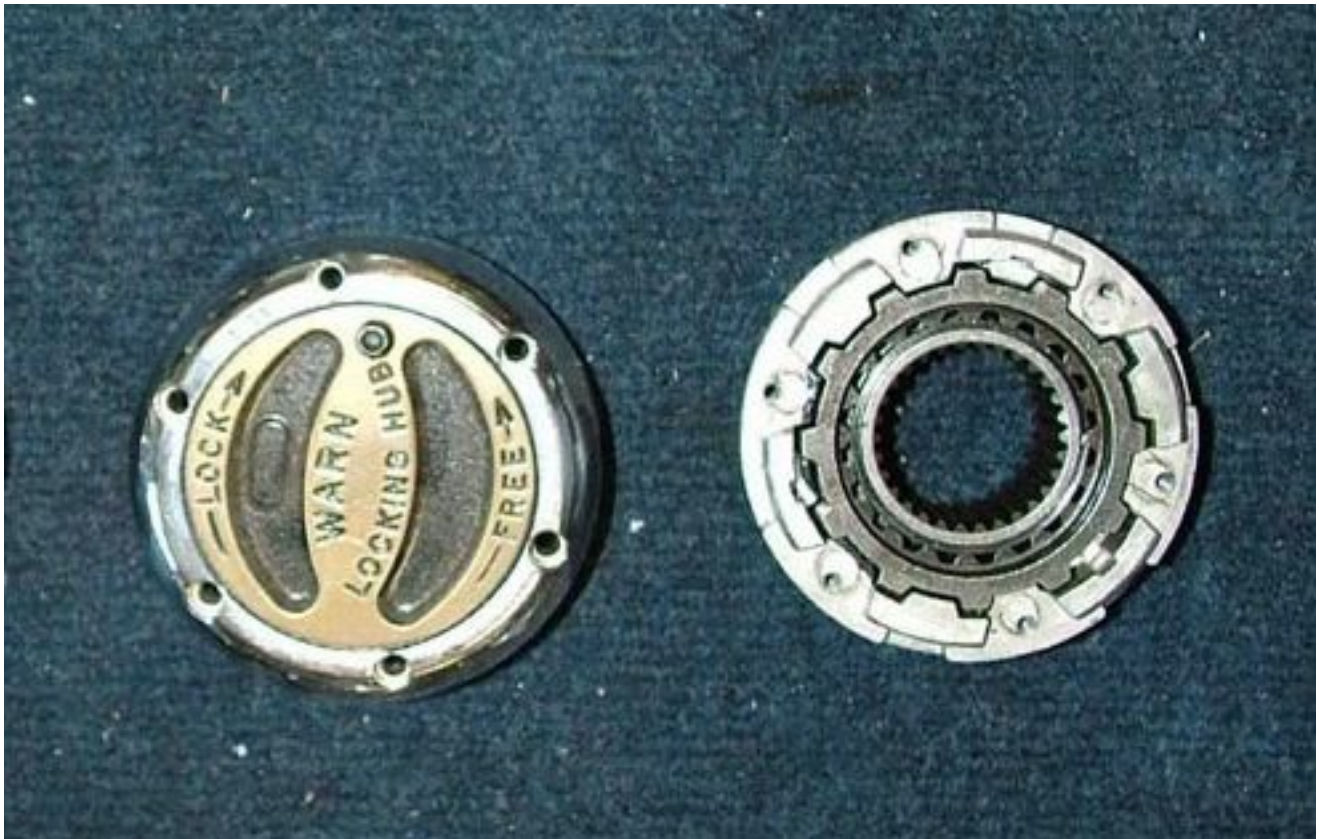
Warn use similar locking ring and fixing screw principles

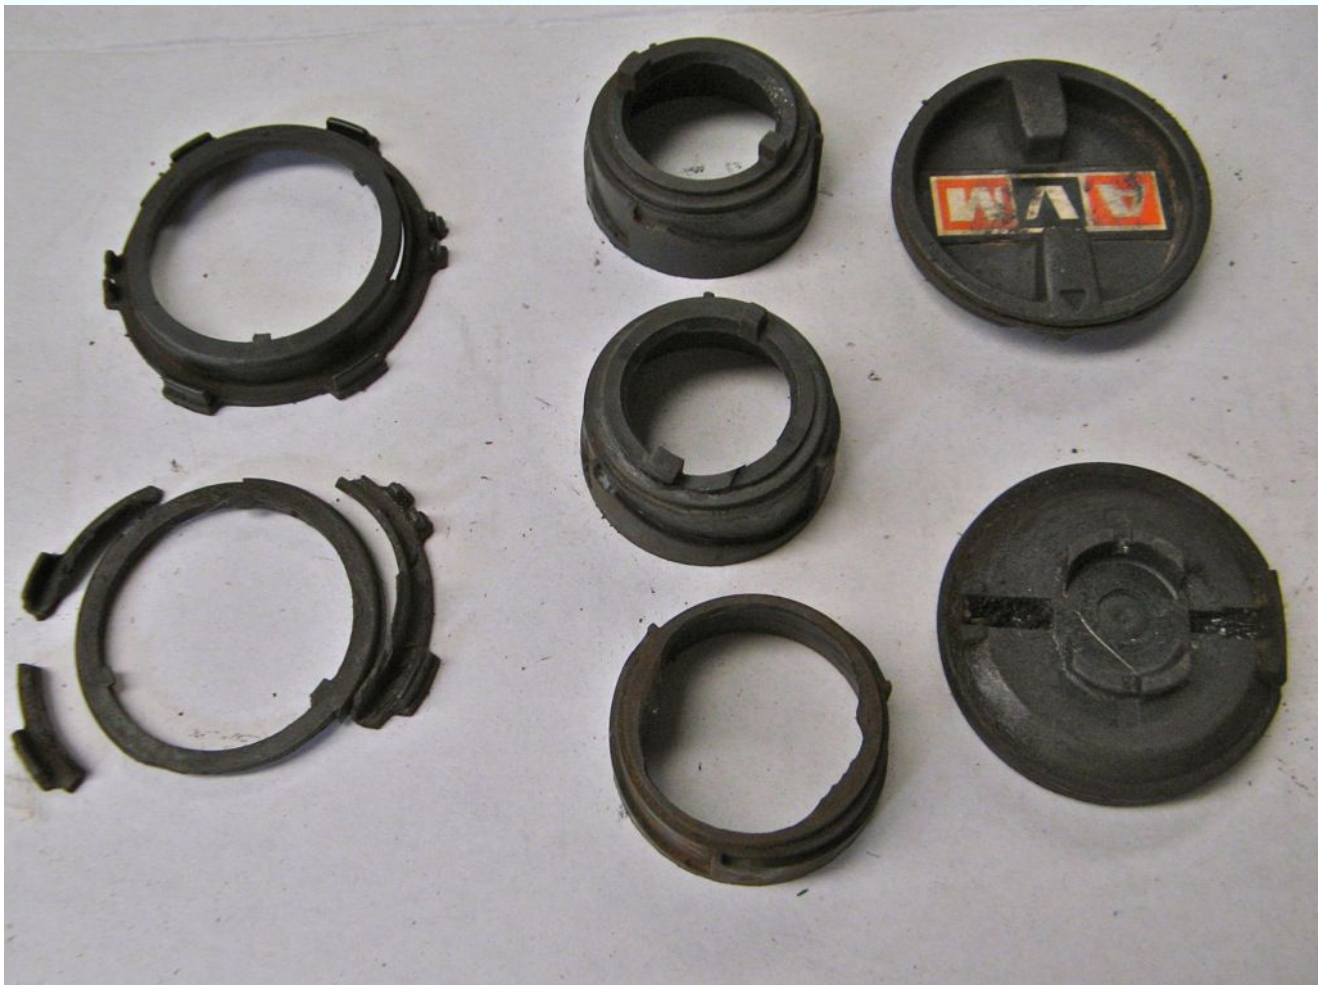
The plastic parts that can break. The ring with tangs, the grooved cylinder and the control lever

In my experience the primary problem is the tangs on the plastic ring which either wear away or break off. This leaves the hub either unable to engage or disengage 4WD, or, when one tang breaks off, the hub is left partly engaged and clicking as the wheel rotates. There is only a 90° turn in the control mechanism (unlike Warn's 325°) which puts a strain on the plastic tangs.

To reassemble the outer hub, note that the control lever has 2 slots on the rear which engage the 2 tabs protruding from the grooved cylinder. These tabs *are not the same width* and must be oriented correctly so the Lock/Free positions line up. Refer to the photo of plastic items above.

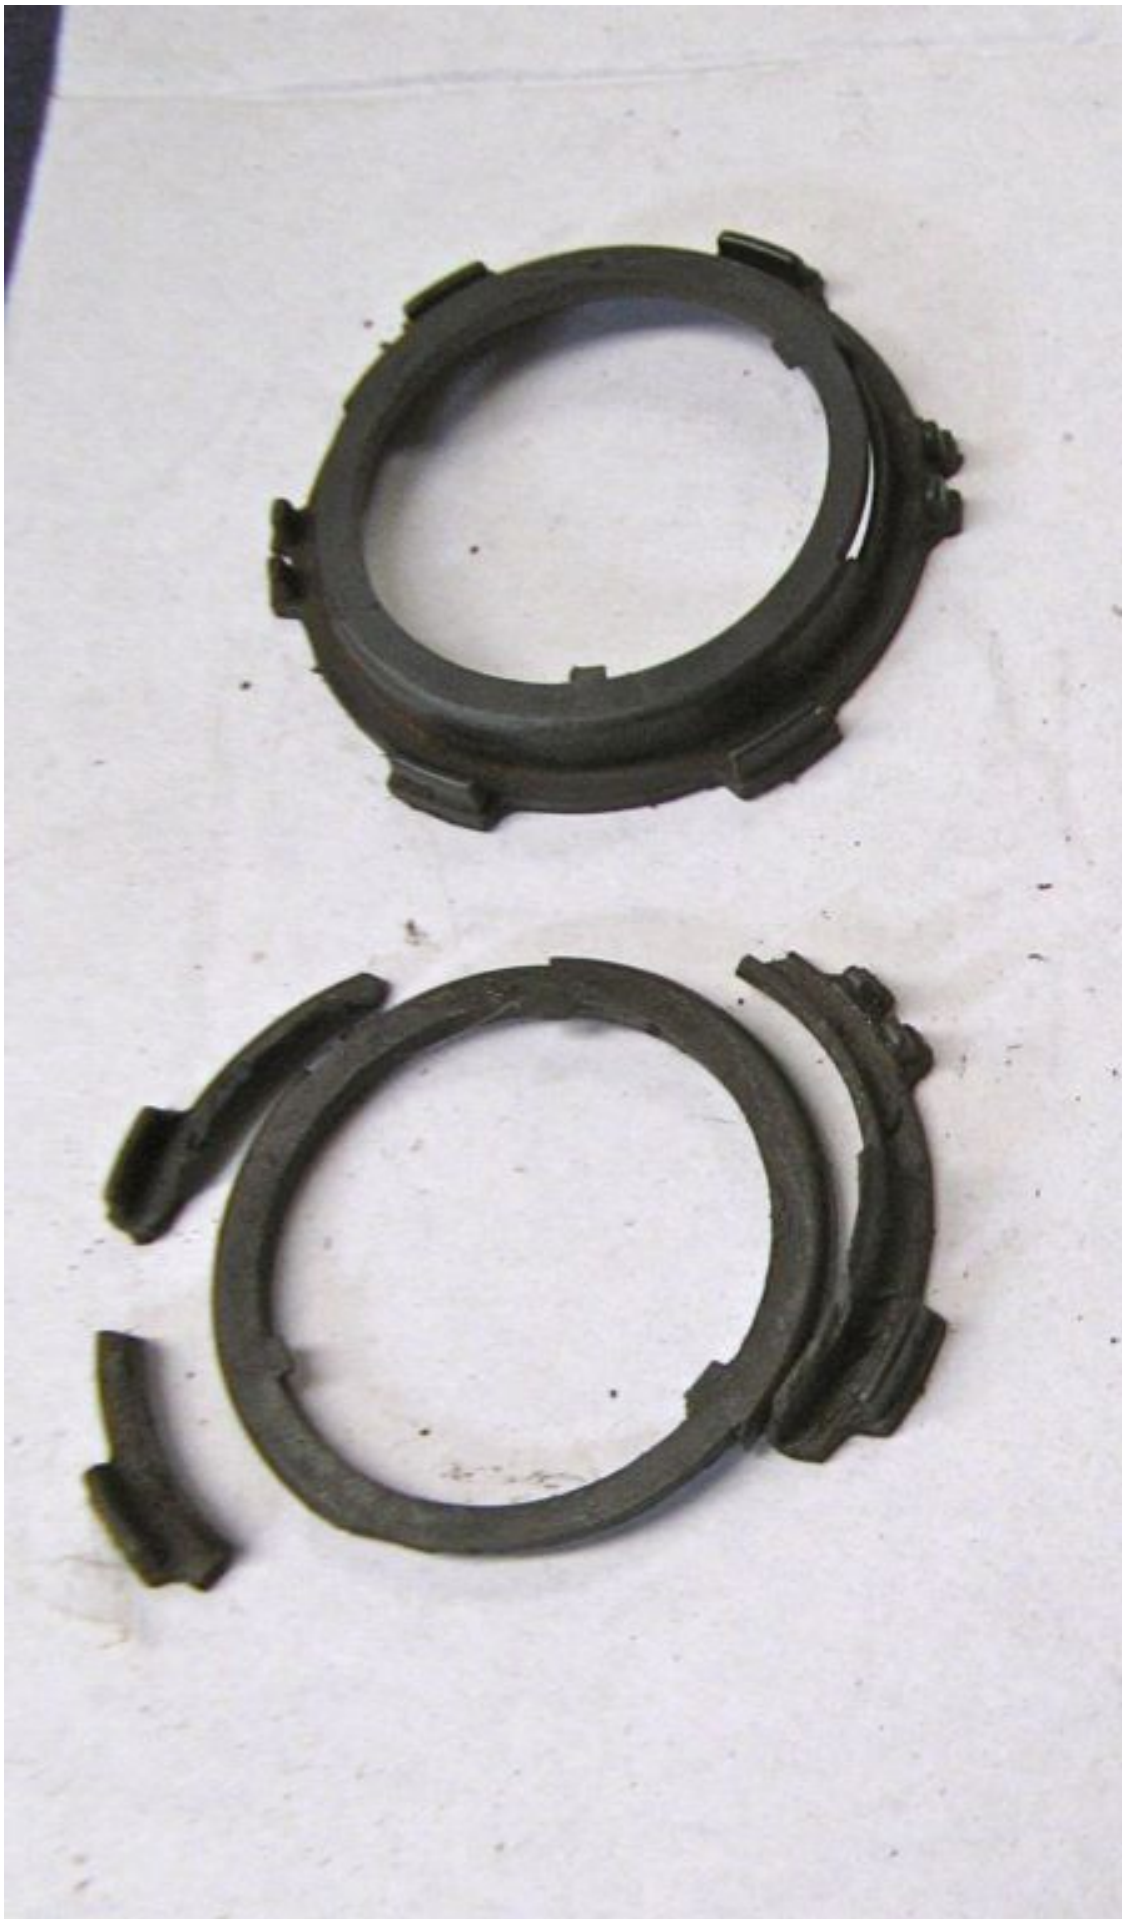
2 broken plastic rings. The top one is complete except for one broken tang. The lower one has all three tangs but the sides are shattered.

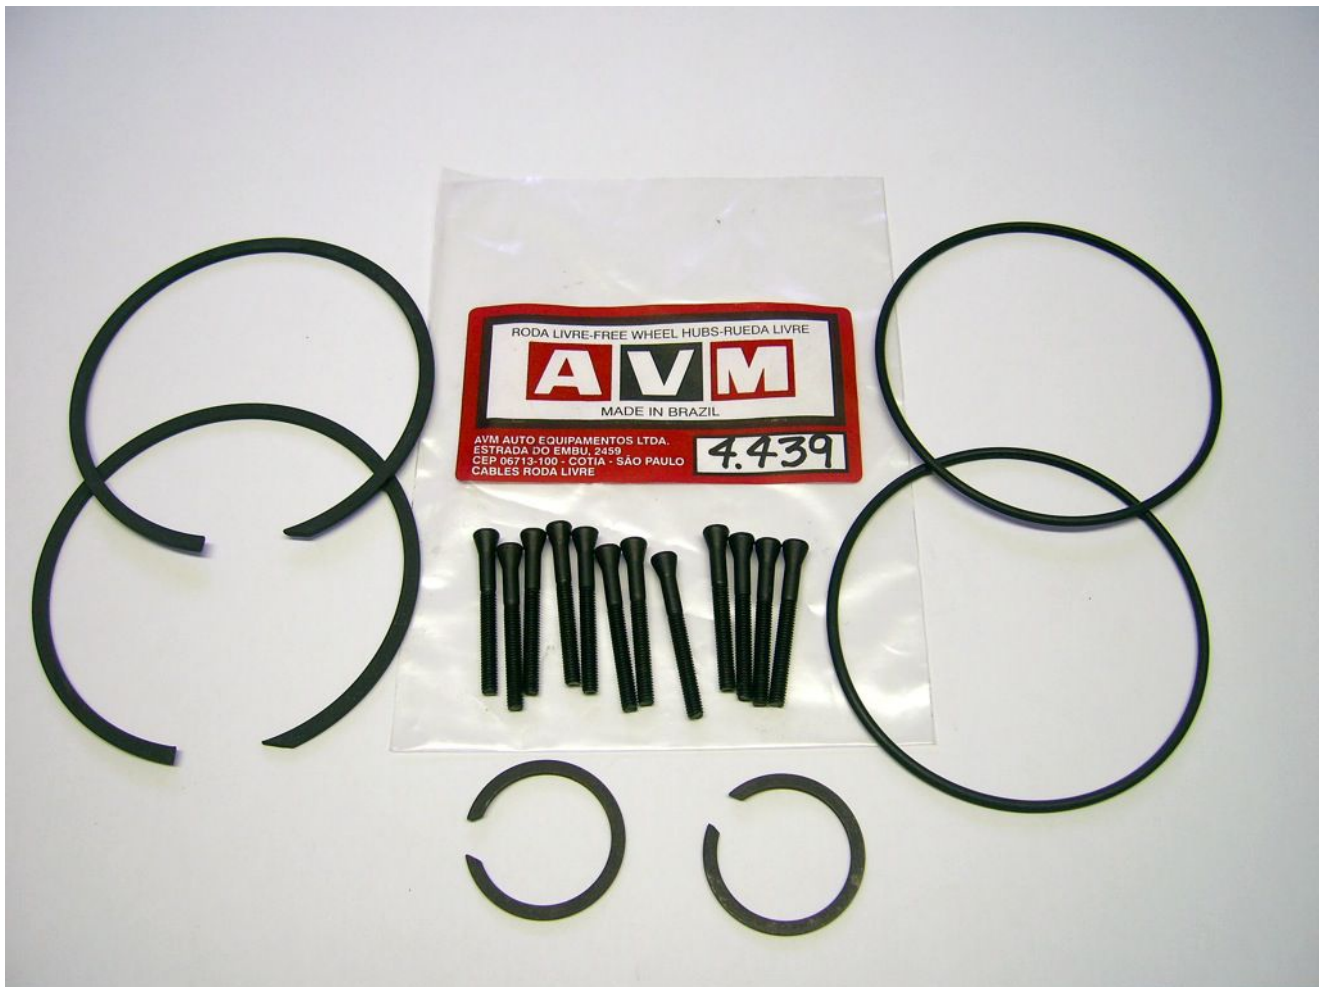
The "service" kit (AVM #4.439) comprises only 2 sets of replacement screws, large O-rings and circlips for the inner hub and splined shaft, which is pretty useless.

AVM 4.439 Service Kit

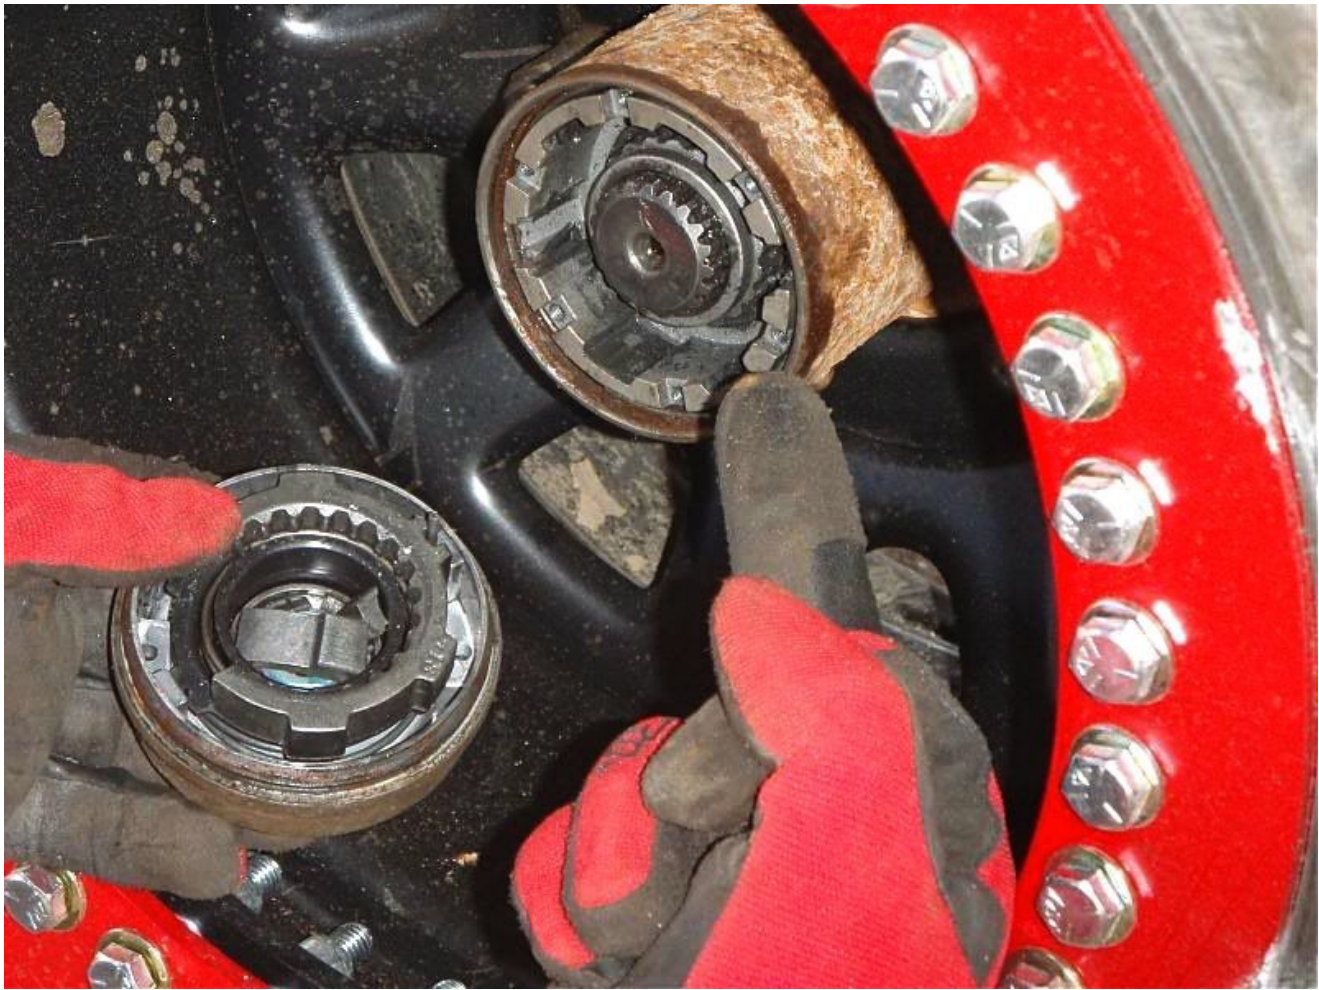
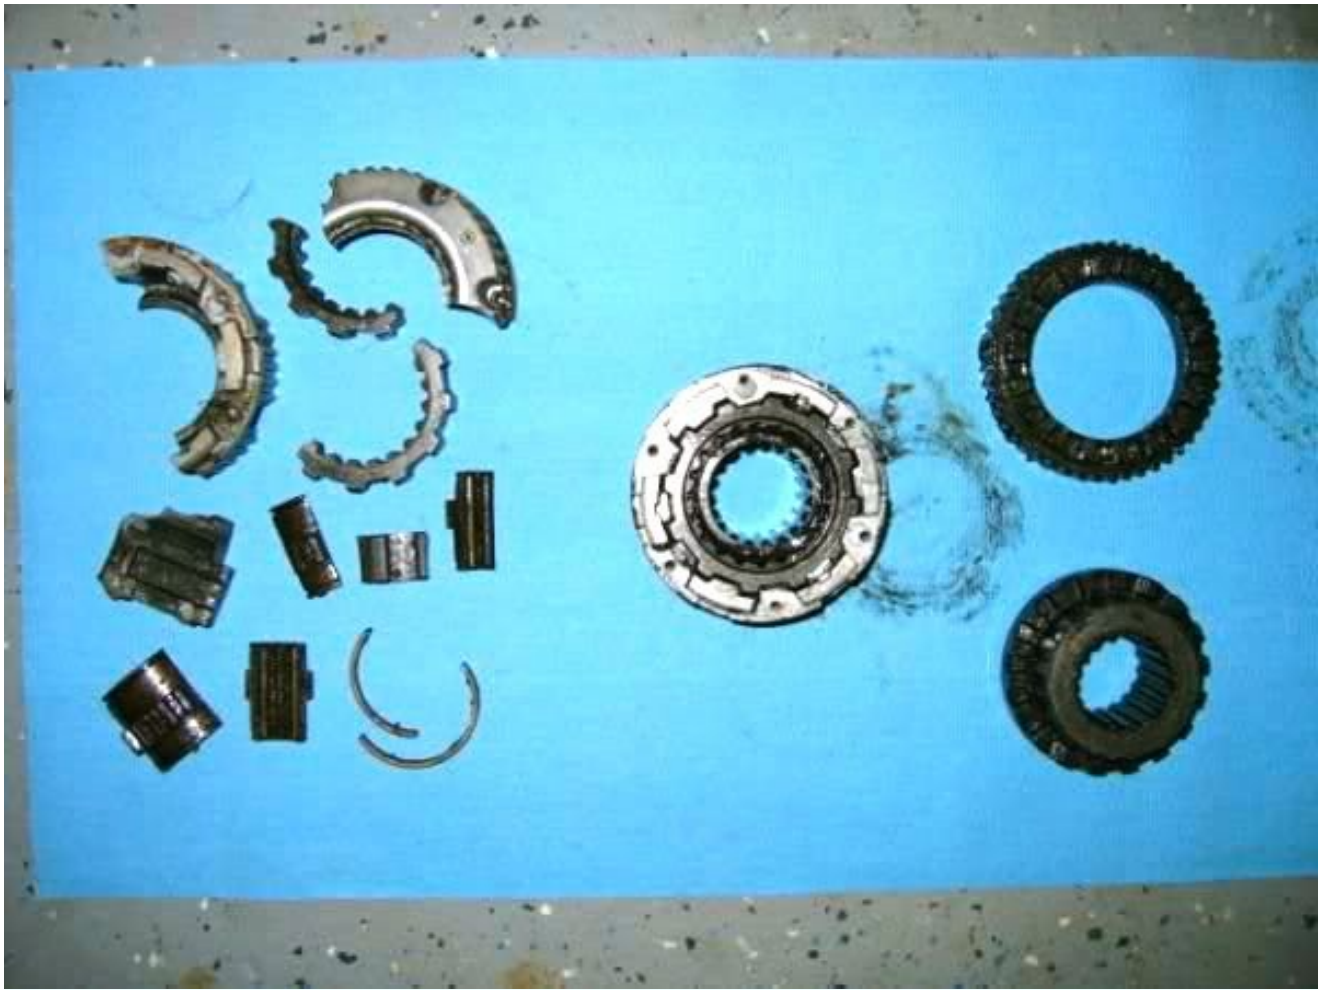
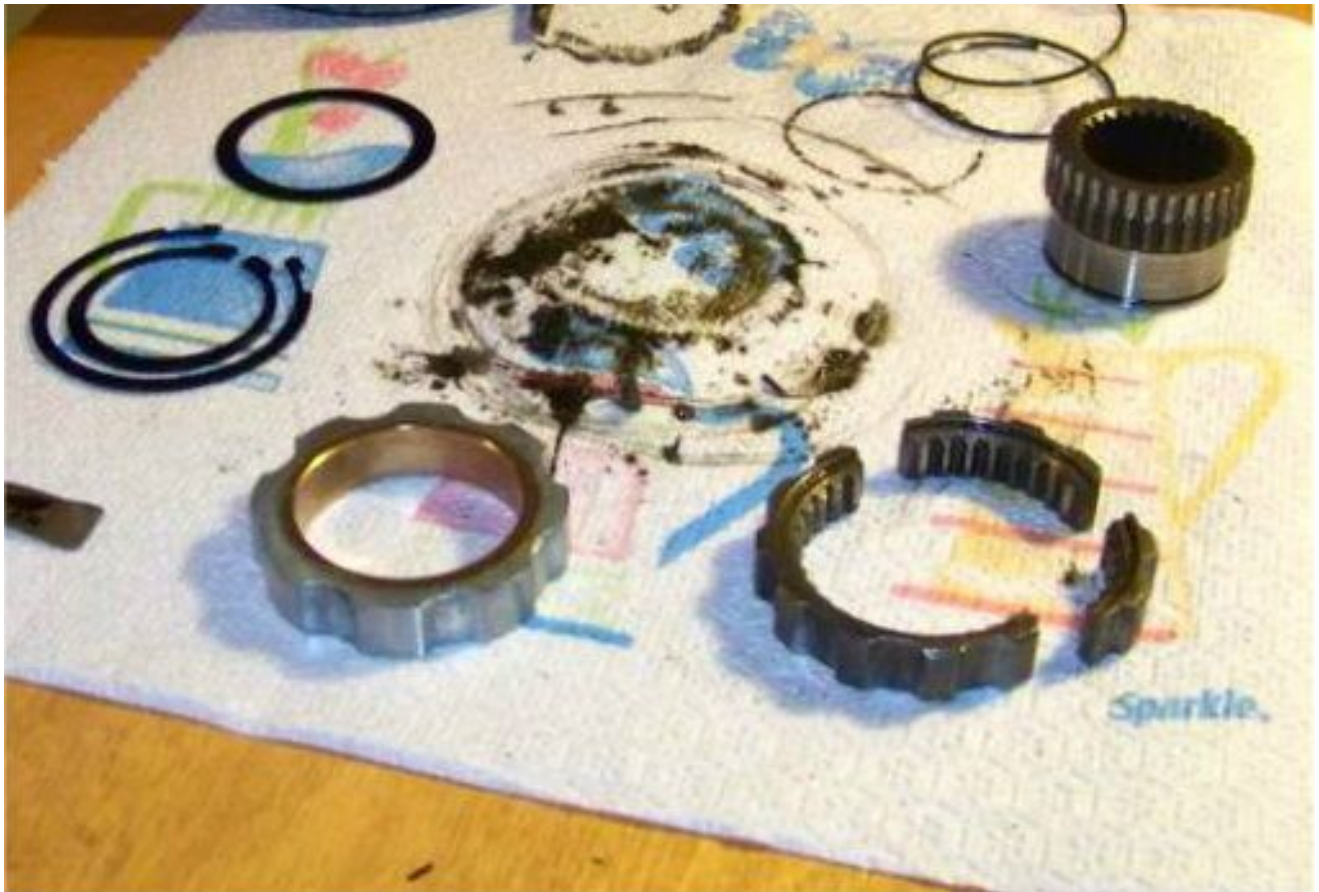
Although Warn is touted as a superior make, a brief search indicates there are cases of failures in their hubs too, but their problems seem to be mainly shattered locking rings rather than the control mechanism. The Warn locking ring *appears* to be slightly thinner than the AVM equivalent but has more cams.

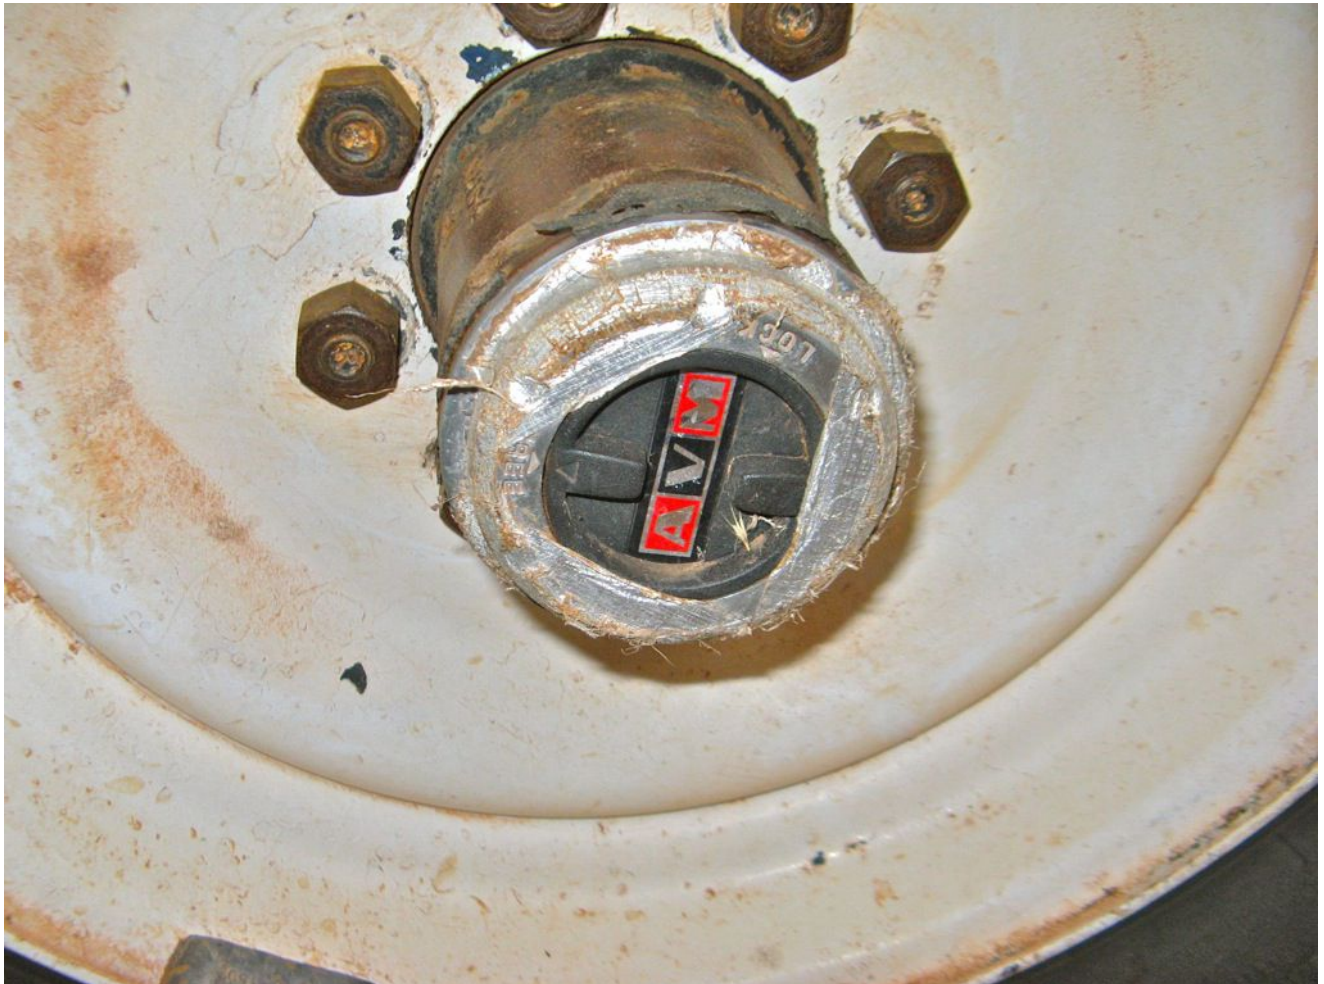
- *Screw heads held captive by aluminium tape*

- Loctite the long fixing screws. This will work but makes their removal potentially difficult and might mean drilling them out.
- Put tape over the heads of the screws so they can't come out, or if they try too it's easier to spot.

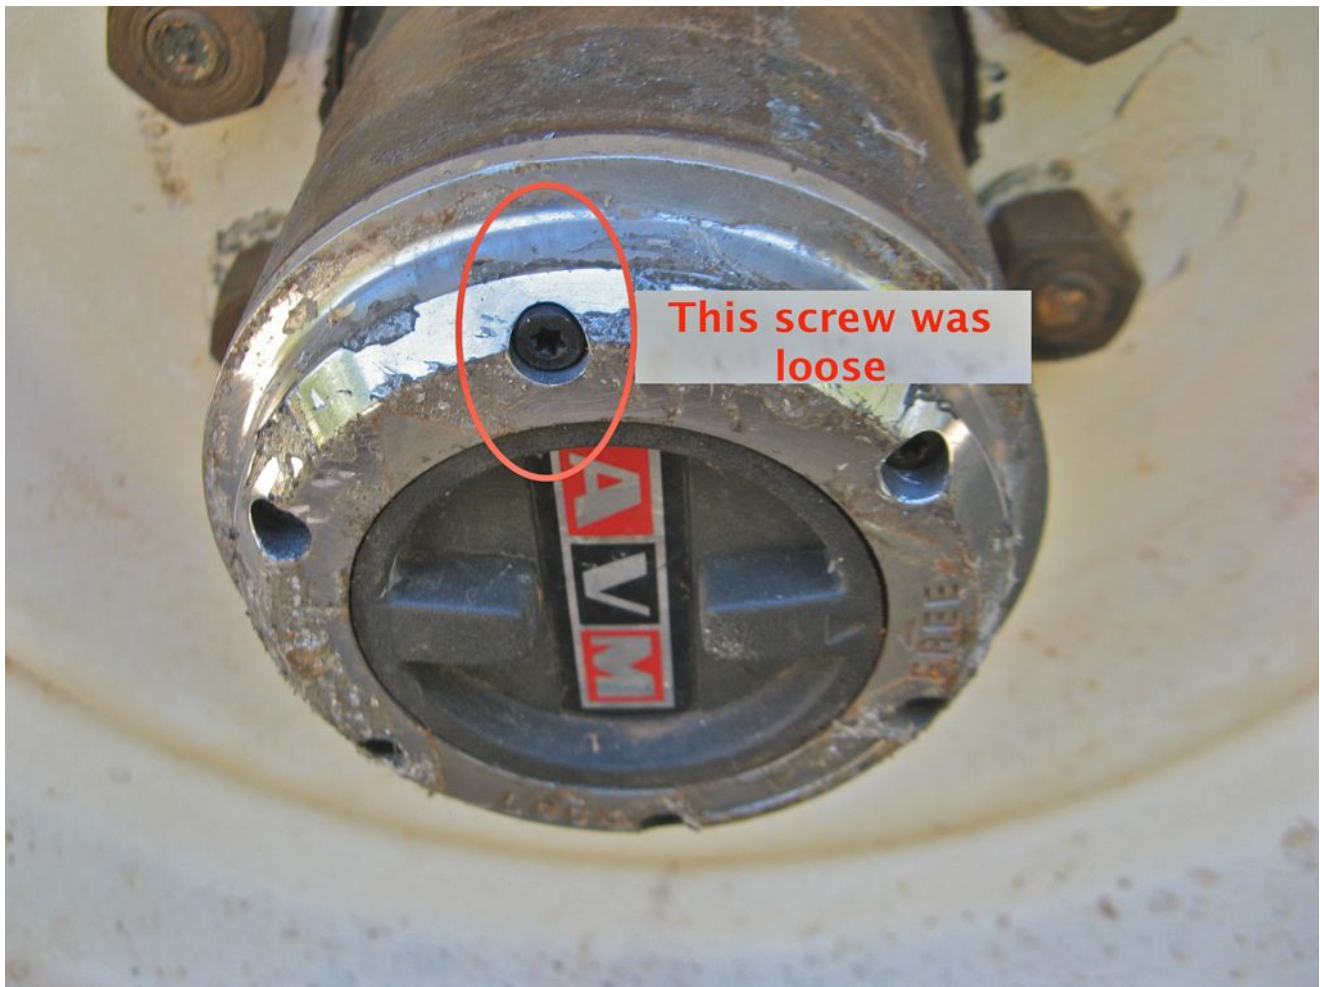
After removing the tape 9,000 km later, 2 screws were loose and this one would have fallen out, but for the tape holding them in.

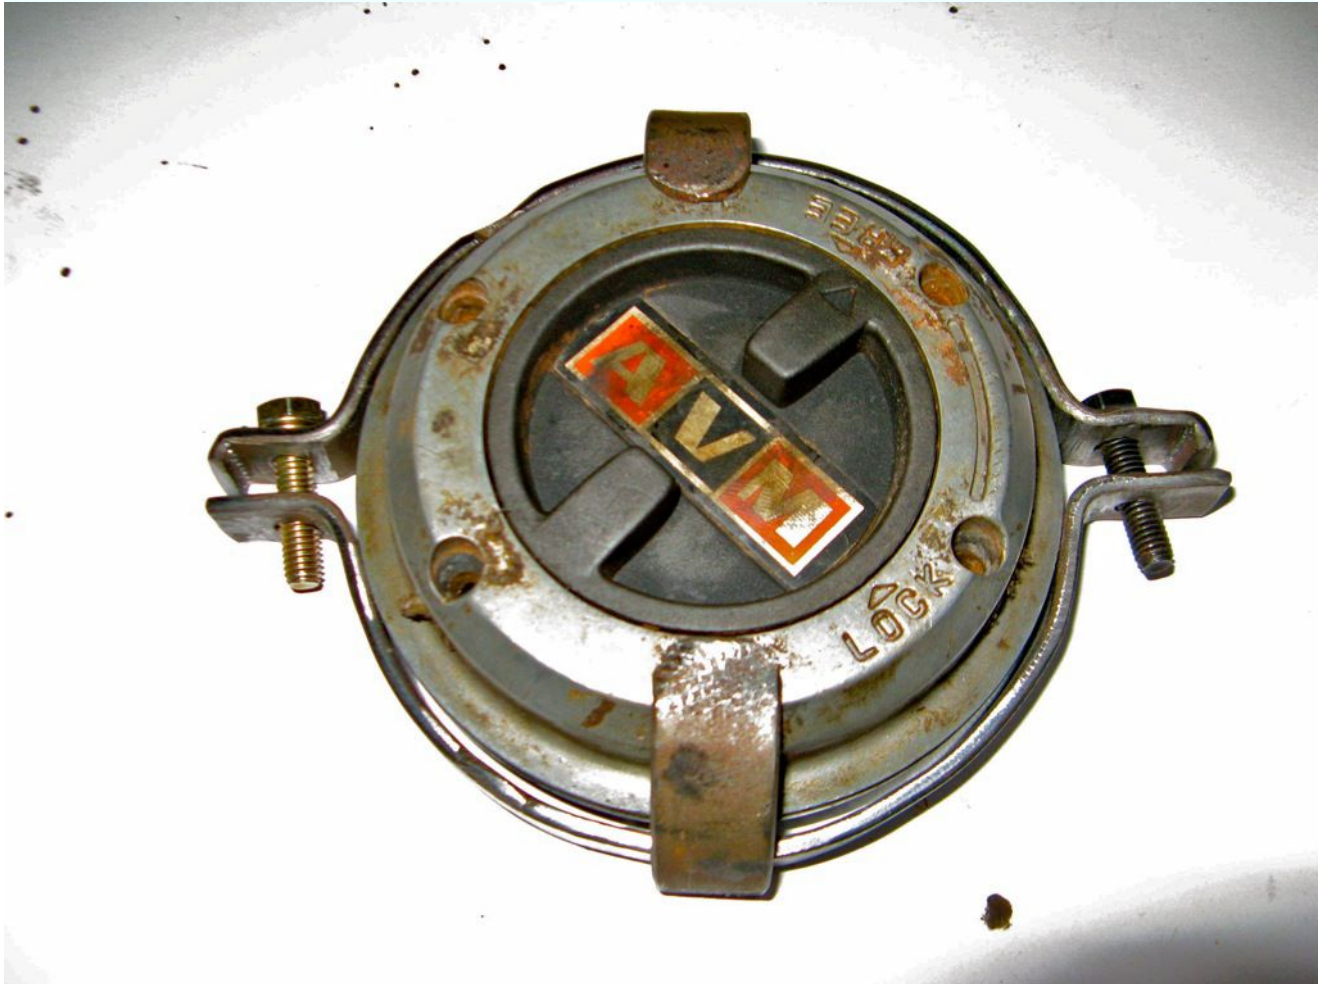
Prototype claw clamp/step ring retention method

- Fabricate a steel ring clamped to the hub (or use the step ring where fitted), with 2 or more claws welded around it which fit out and over the hub screws to

retain them and the outer assembly. The claws will not impede access to the control lever and the ring can double as a non-slip step ring. A thin flat ring could be welded to the ends of the claws to retain all the screws and avoid them catching on passing flora. I'm implementing this concept and incorporating hub steps.

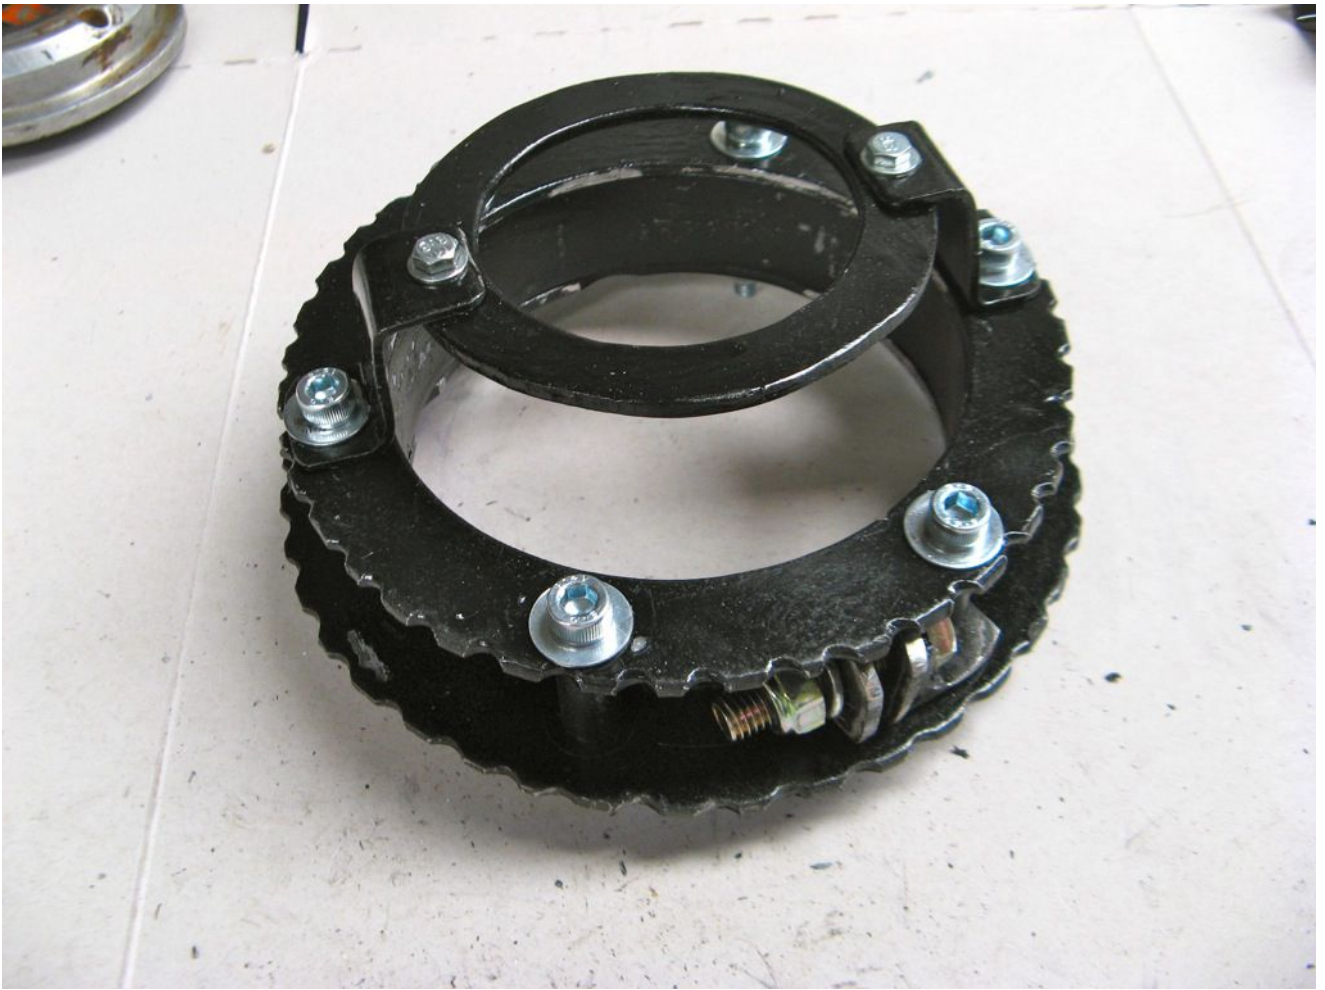
The final design incorporating non-slip step rings

In this design the clamp ring is a 2mm x 25mm steel band but the steps are 3mm aluminium plate because it's easier to work with and lighter. 3 steps rings could be used á la Oka, but I'm not sure the inner ring is very useful.

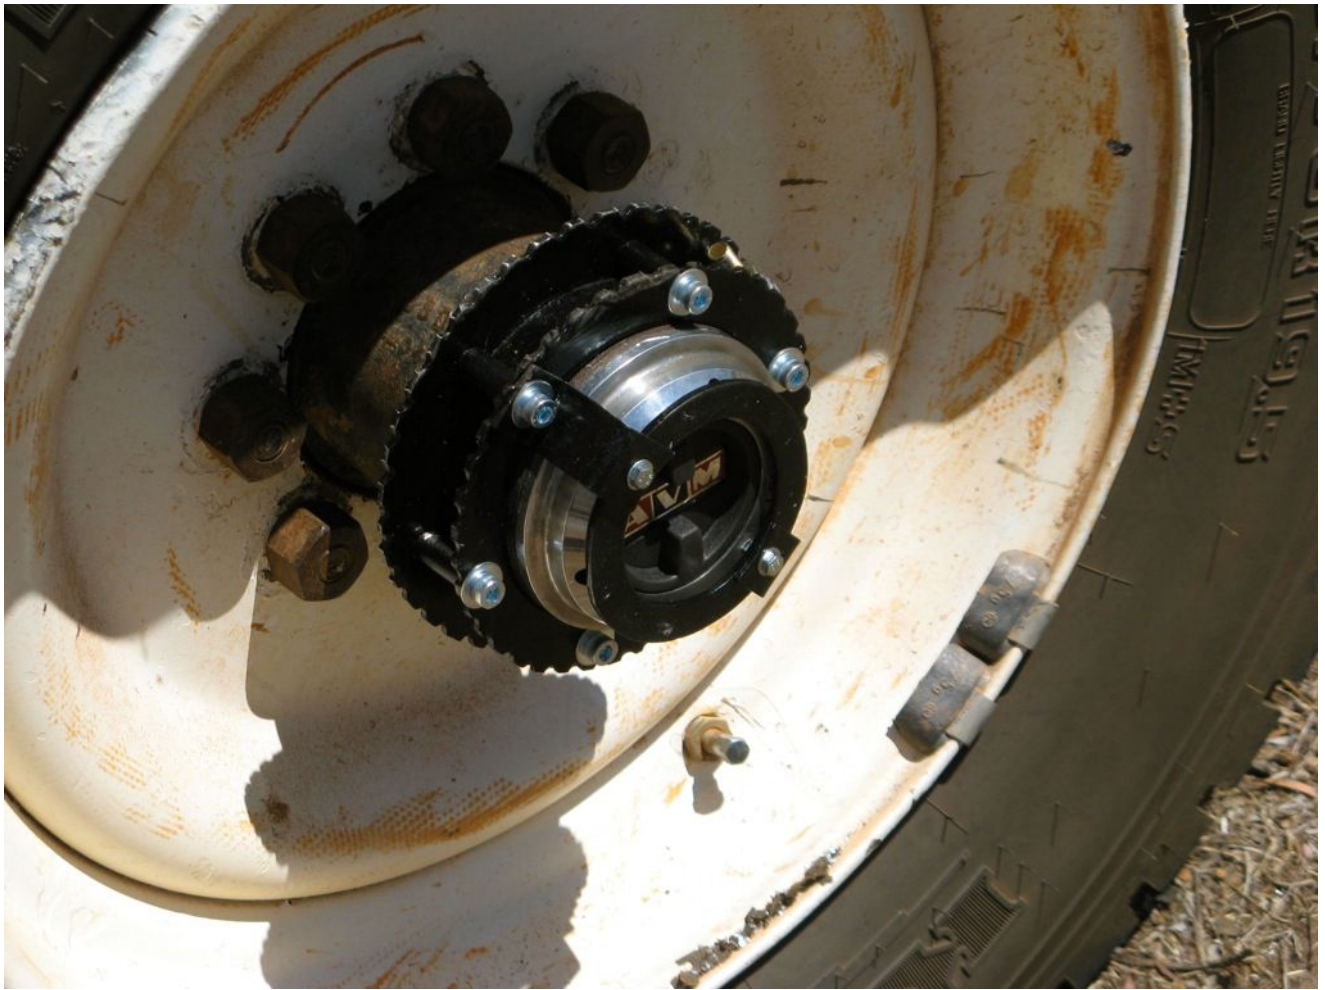
Hub step in operation with FWH retention ring
