Free Wheeling Hub Maintenance

Many Oka owners have AVM freewheeling hubs and several (including me) have had on-going problems with them.

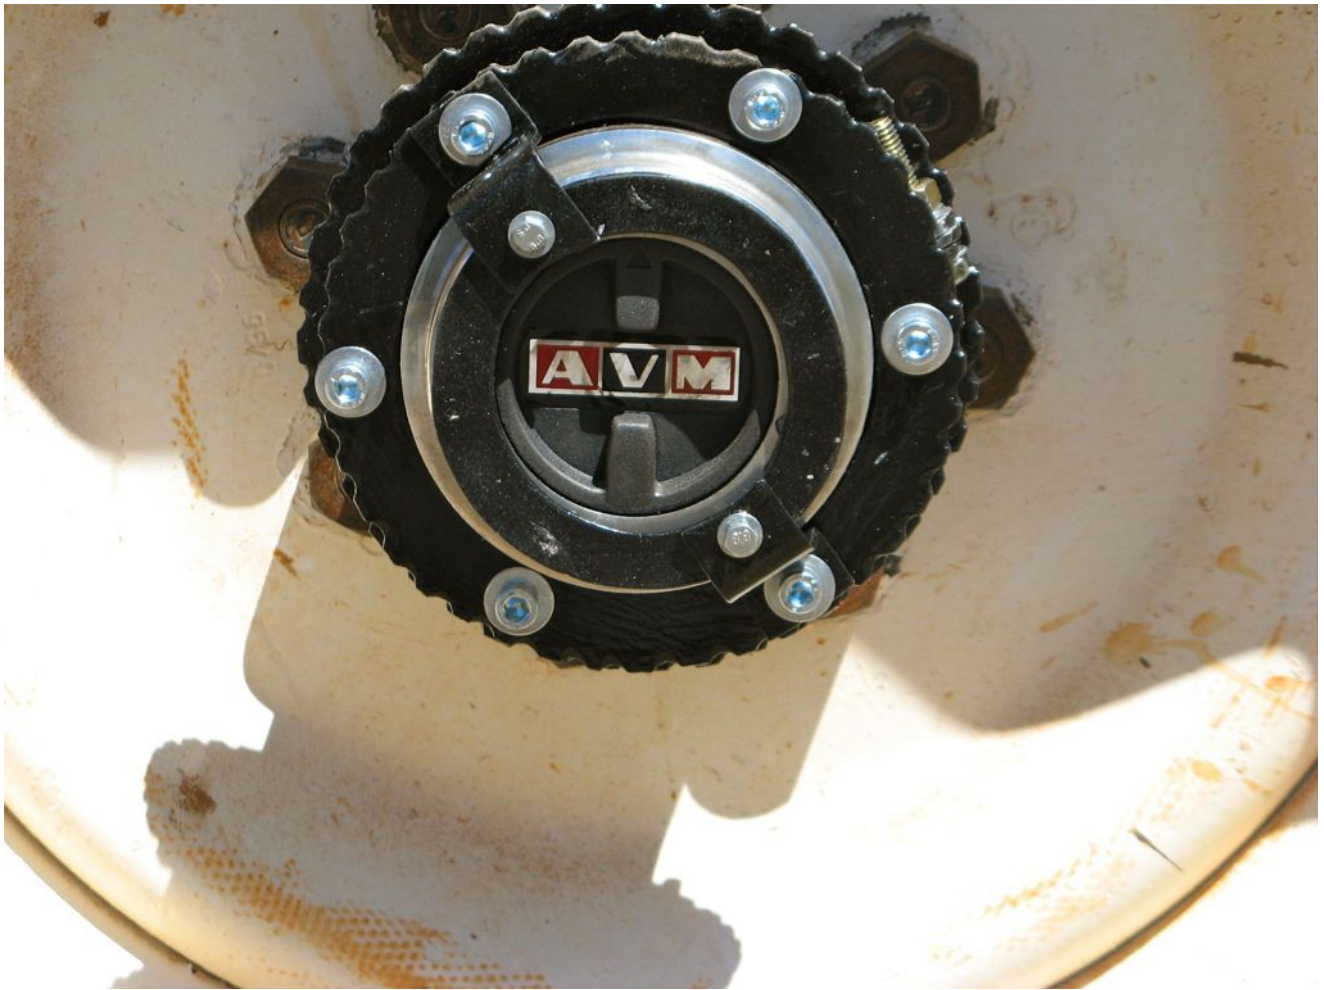
The control lever is still accessible (CW to lock, CCW to unlock)

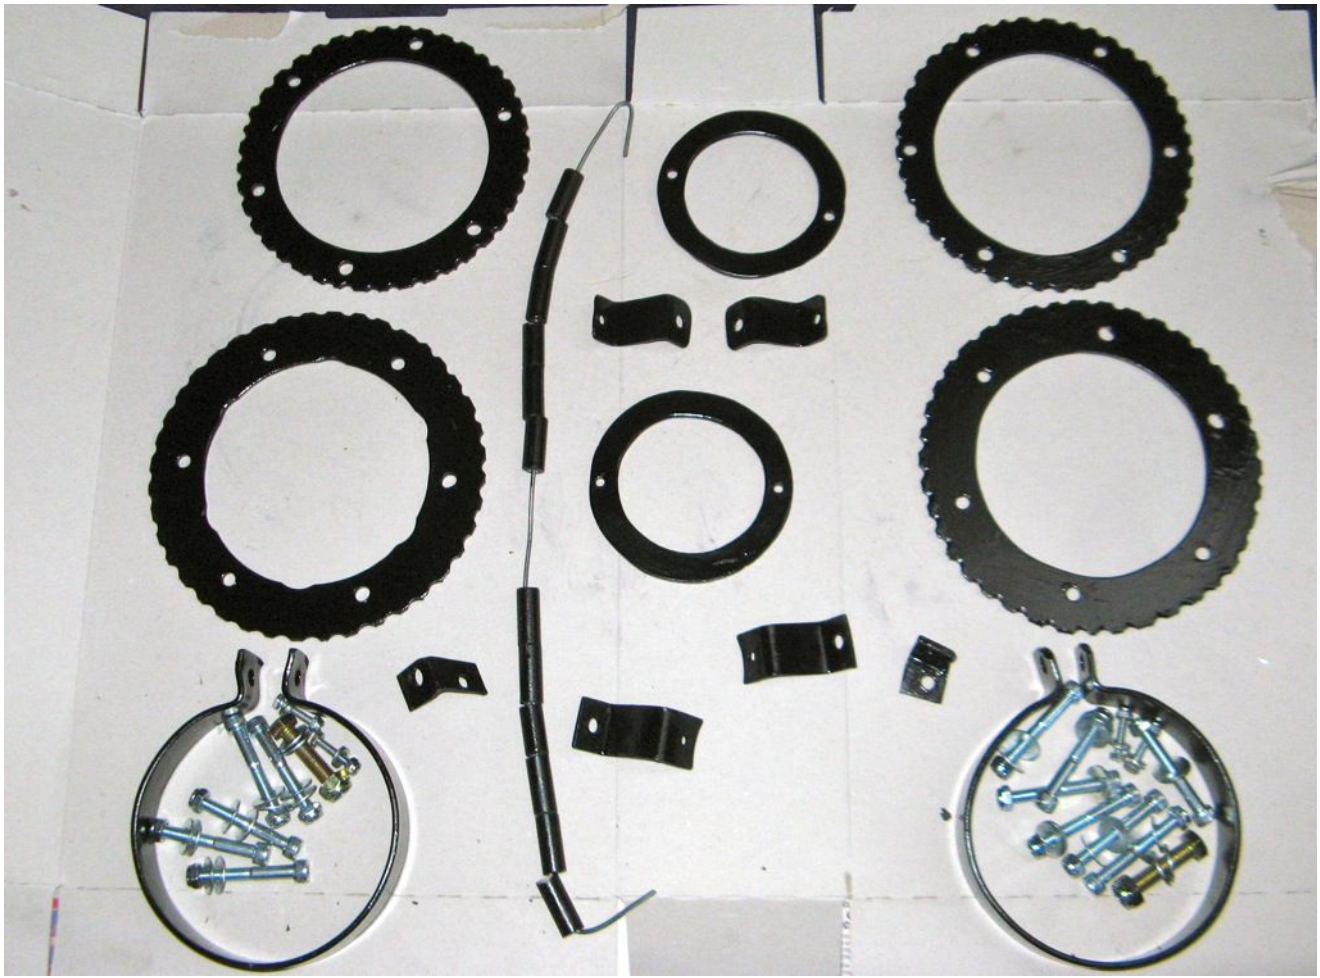
Step ring and retention ring components

The step rings are clamped either side of the steel clamp band by long bolts and spacers so they can't move laterally. A small bracket secures the rings to the clamp band bolt so they can't rotate.

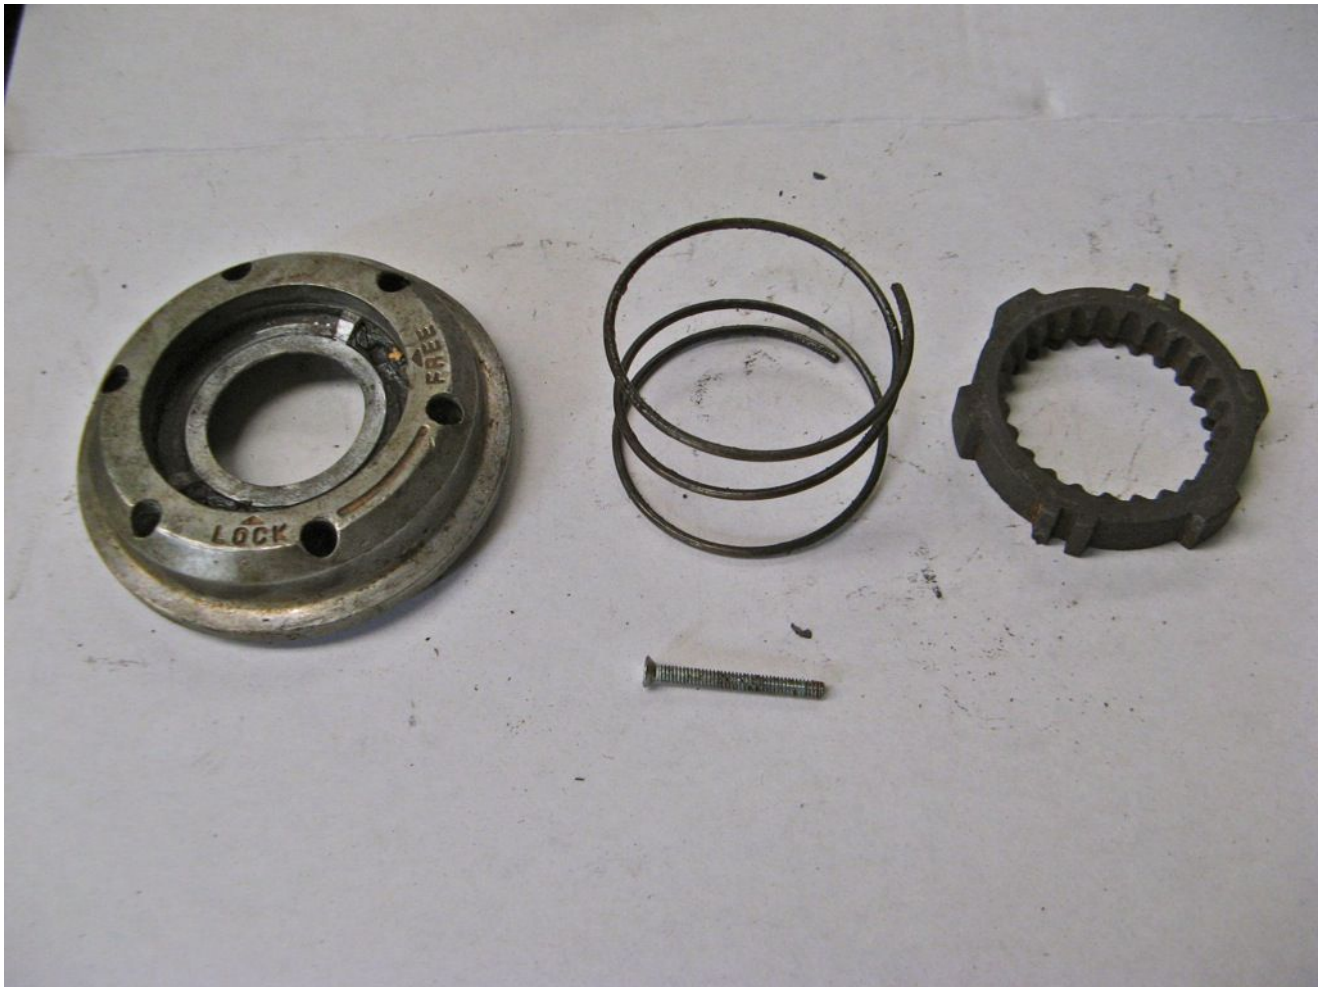
- Either a complete spare outer hub assembly (obviously) or,
- Parts from a failed outer hub assembly:
- the aluminium frame (the alignment roll pins are not necessary and could be removed),
- a locking ring,
- the large spring, and
- a few of the long screws.

Components needed to engage 4wd

To lock the hub into 4wd, insert the locking ring, *bevelled edge first*, into the inner hub gear and bolt the aluminium frame on to the hub, compressing the large spring between them. Only a minimum of 2 or 3 screws are required to hold the outer frame on since there's not a huge force against it, and in 4wd, all the hub components rotate together. Put some tape over the screw heads so they can't come loose.

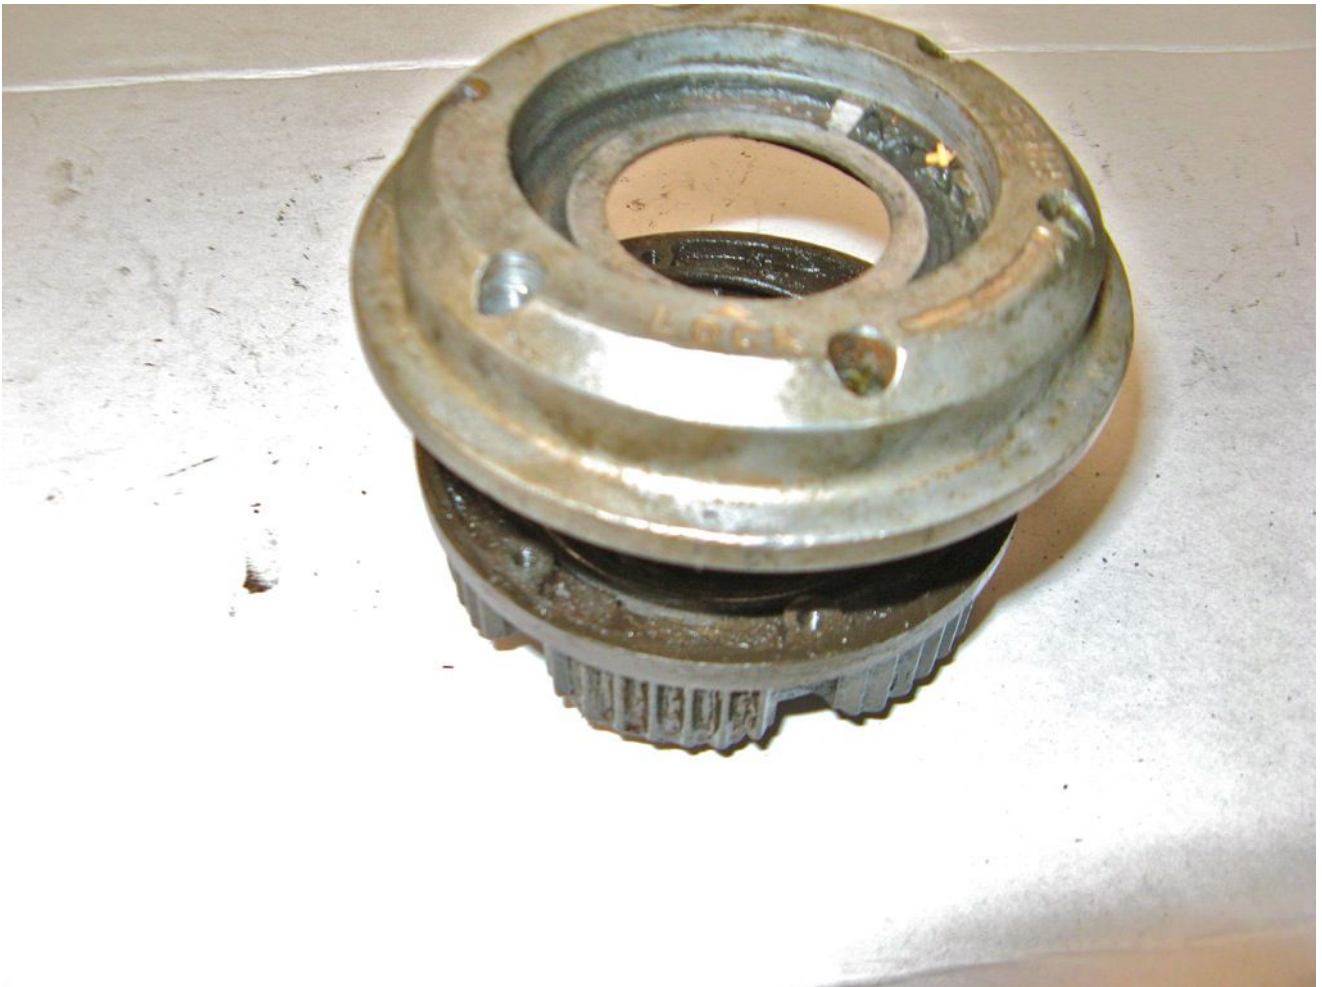
The outer frame and spring push and hold the locking ring into the inner gear assembly, locking the hub

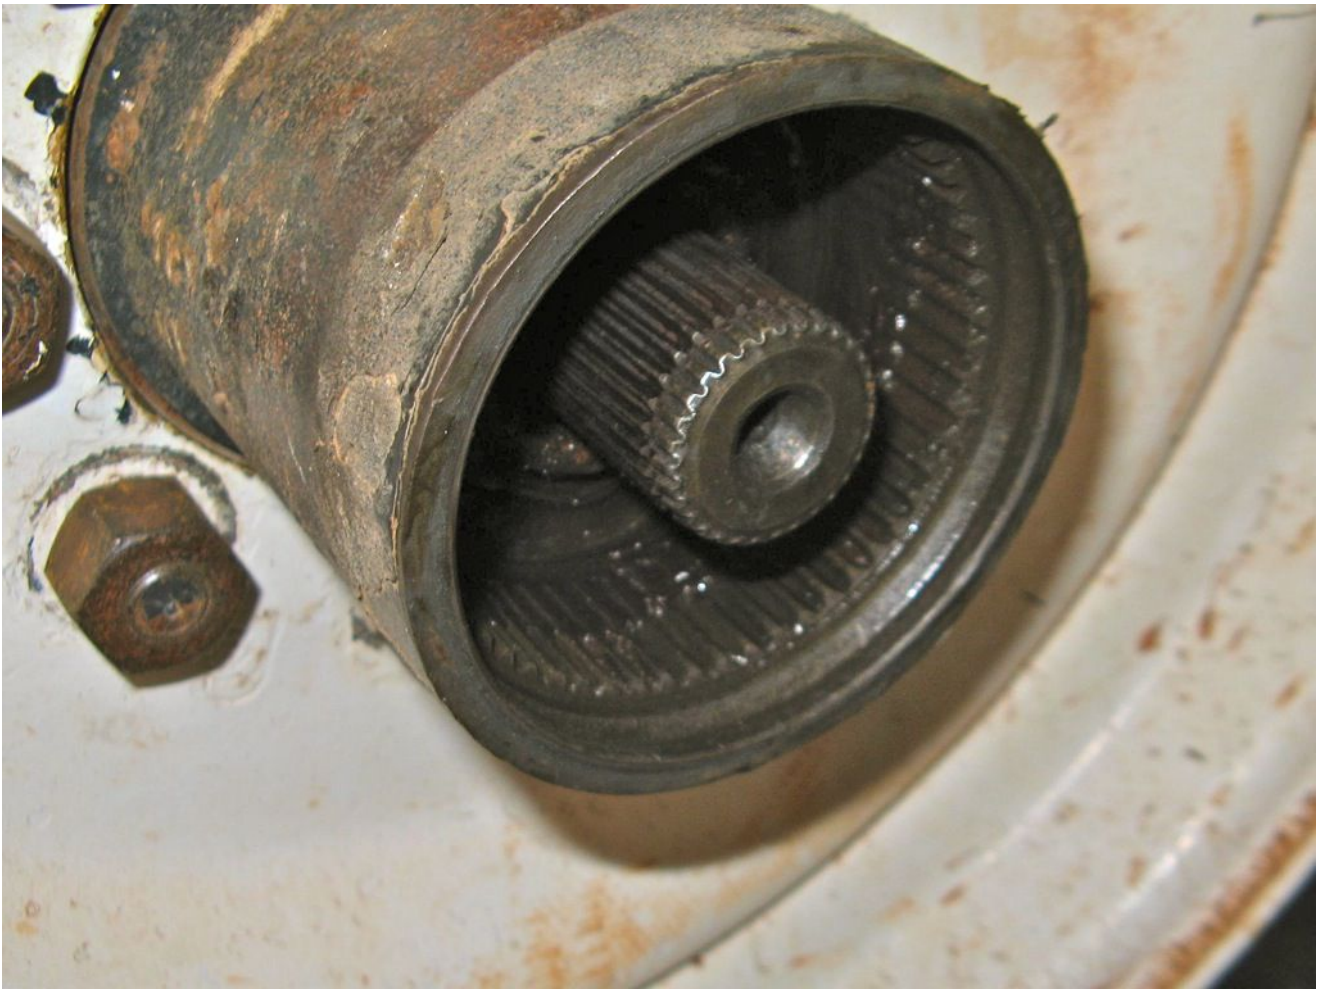
The inner assembly is held in place by a large circlip which sits in a lipped groove in the hub, behind which is a bevelled edge prior to the internal splines. It is therefore possible and desirable to fit 2 circlips.

The groove is wide enough for 2 circlips to hold in the inner assembly

The reason is as follows. The locking ring begins to engage the inner gear when the spacing from the outer hub face to the inner gear face is about 6mm. This is very close to the normal unlocked separation of the inner gear and locking ring, which is why a single broken tang can cause clicking. The long screws actually draw these faces together when tightened and anything that can increase the spacing minimises this problem. Fitting 2 circlips will achieve this.

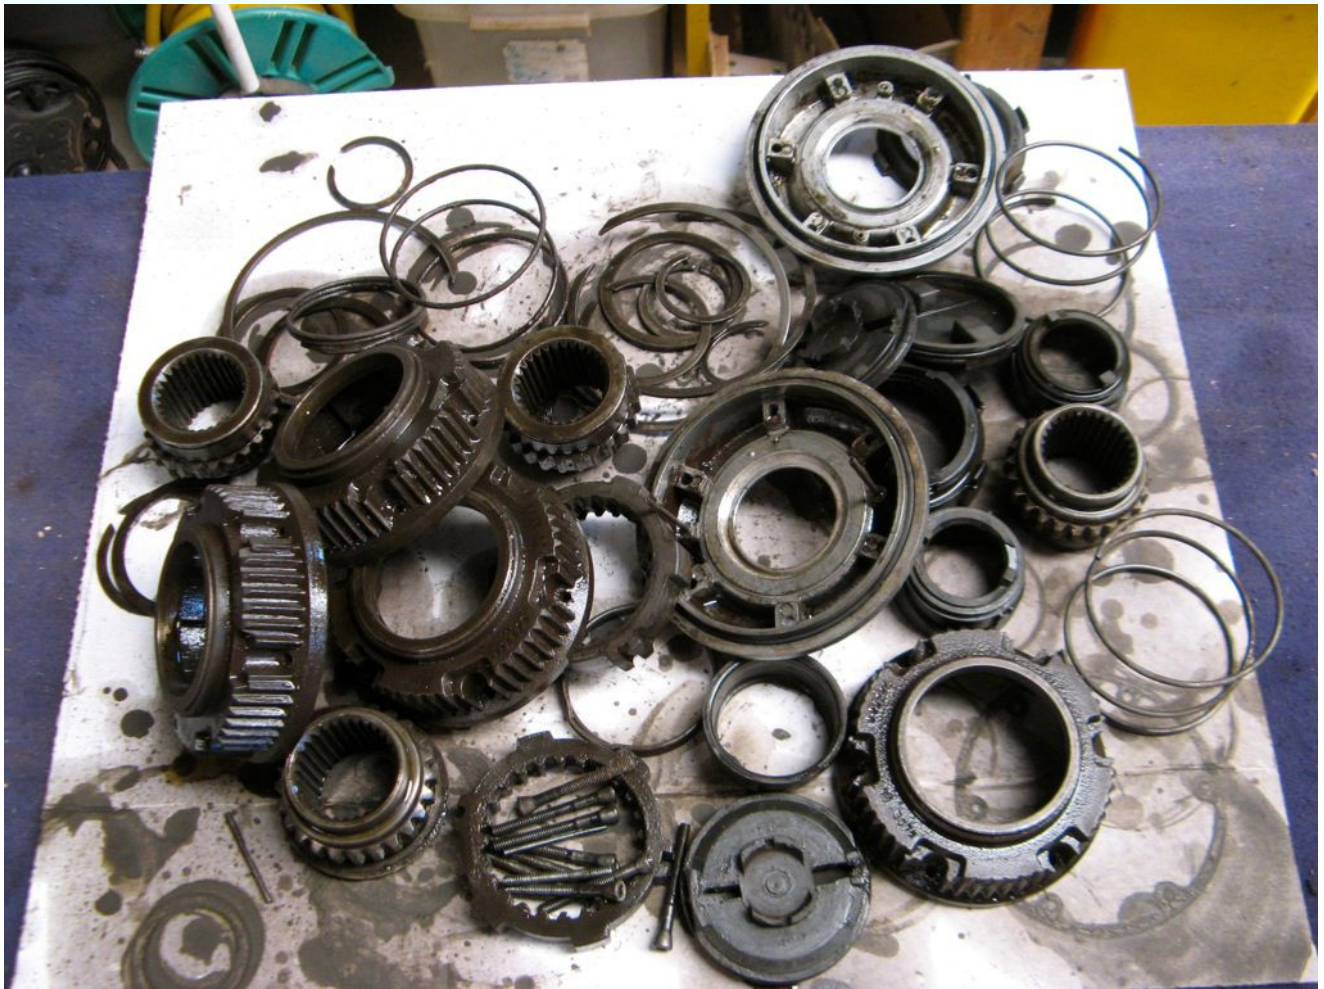
My pile of AVM free wheeling hub spares, **not** including the 2 on the Oka

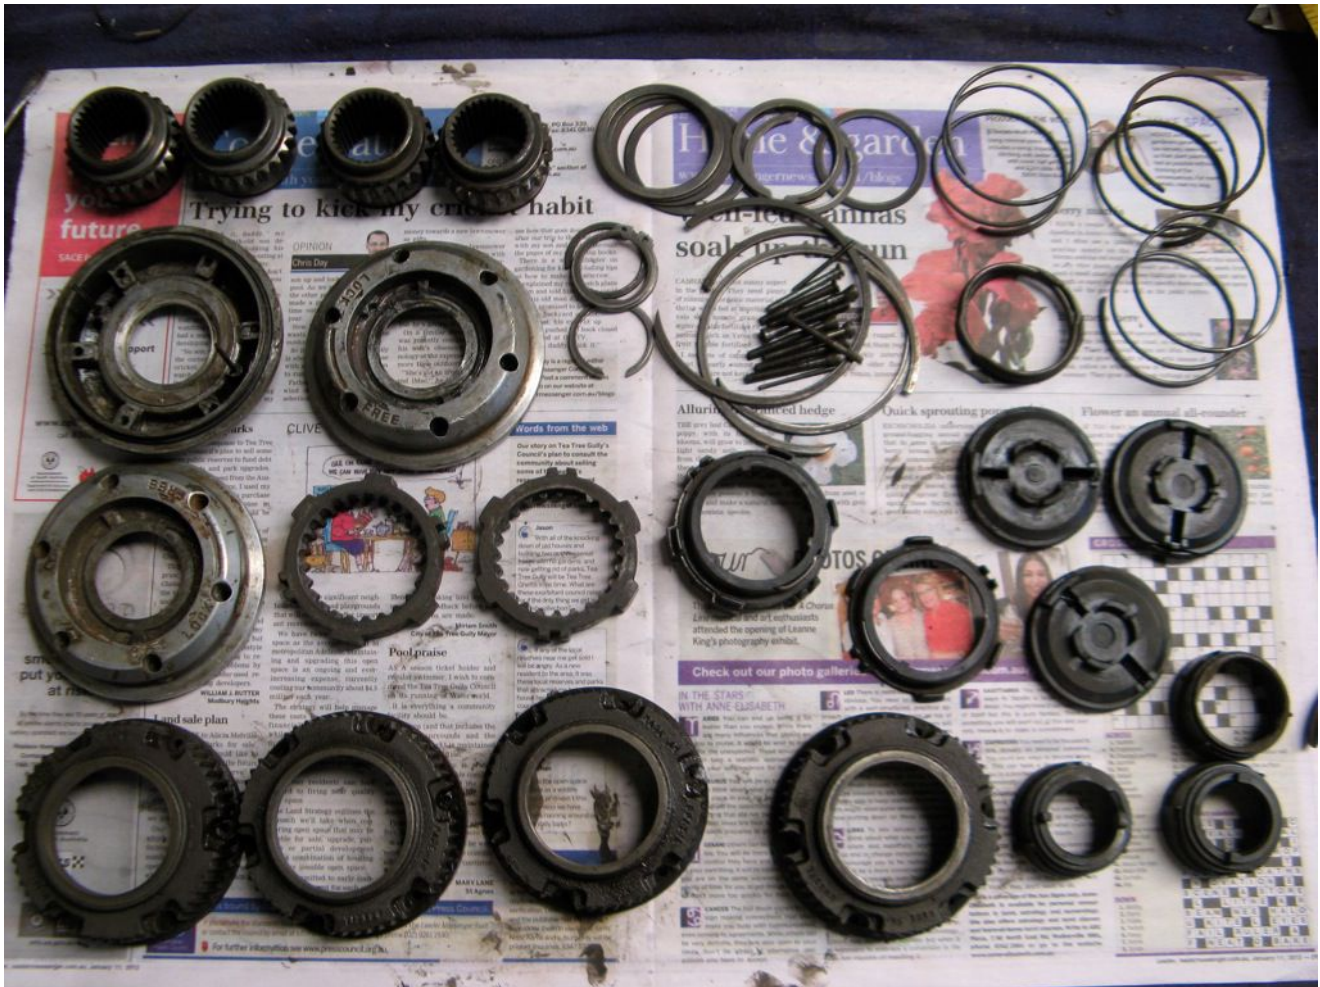
All the mechanical components are reusable, but very few of the plastic parts are

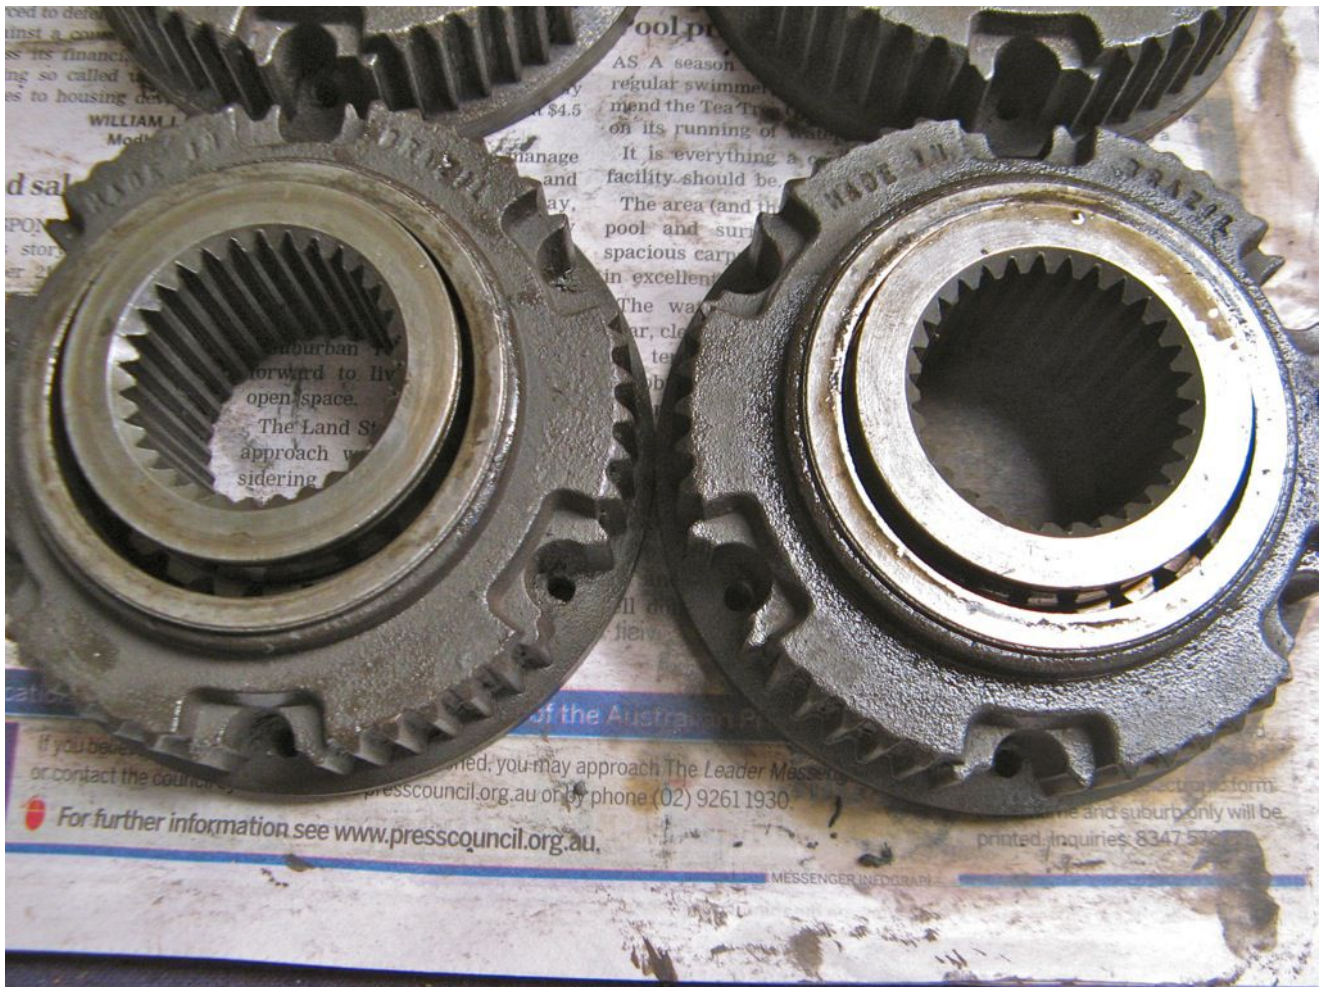
Note the opening (not the spine gear) in the rear of the inner ring on the left is larger than the one on the right.

The inside diameter of the left hand gear is 50mm whereas the right hand one is only 49mm. Although it doesn't sound much, the inside surface of the outer ring, which rotates continuously with the wheel, is what supports the splined gear, which is stationary in 2wd, and 1mm can make a difference. On the larger ring, the spline gear almost falls through the hole.

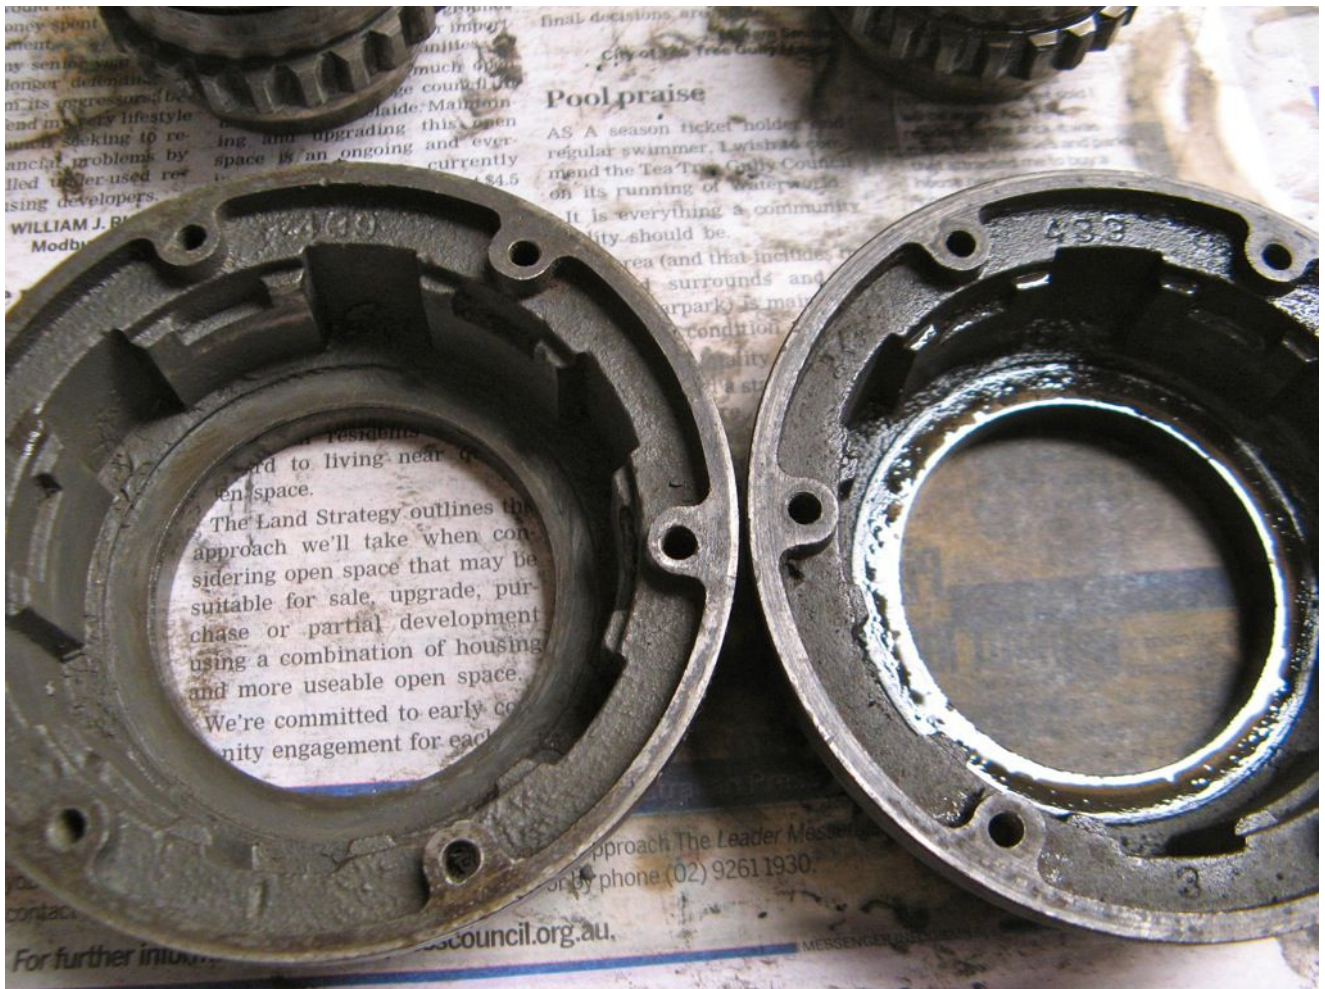
Both types are marked 439, which is the AVM part number for a hub to suit a Dana 60 internal mounting and 30 spline shafts.

Both rings are stamped "439"
