GARP Part 2, the Great Axle Reconstruction Project

Part 2 describes the reassembly process.

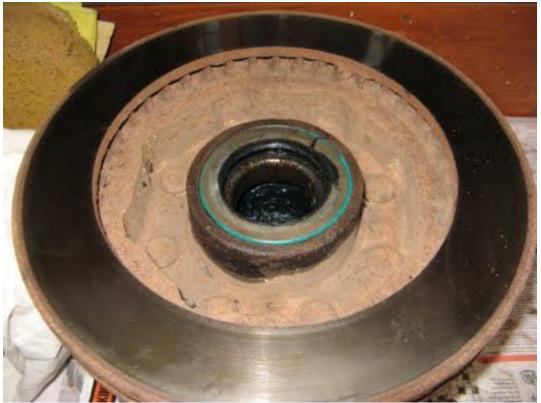
Oil seal inserted into the rear of the hub.

If the hub and bearings can be successfully located on the spindle without jamming, a new oil seal can be pressed into the rear of the hub, by gently tapping around the edge with a heavy hammer until it's flush with the hub casing. Don't knock dirt from the back of the hub into the bearings.

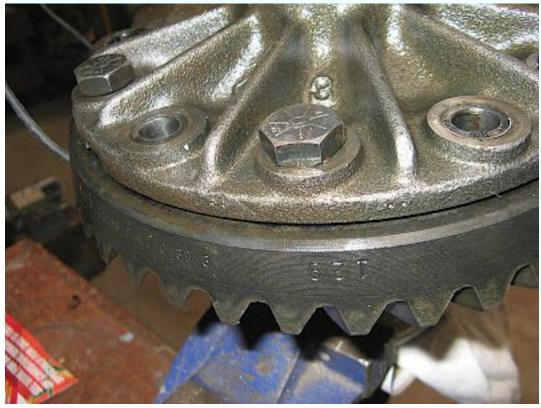
The Ring Gear being removed.

Removing the ring bolts was easier than anticipated since they should have been torqued to 130 ft-lbs (176 Nm) and Loctited too. I left four of the bolts partly in place and tapped them with a hammer to free up the ring gear, which wasn't very tight anyway. I moved the carrier from the vice to the workbench and then removed the last 4 bolts whilst holding the ring away from any hard objects. I didn't want to have to replace that as well, since ring gears only come as matched pairs with the pinion, which would have made it a much more difficult (and expensive) job.

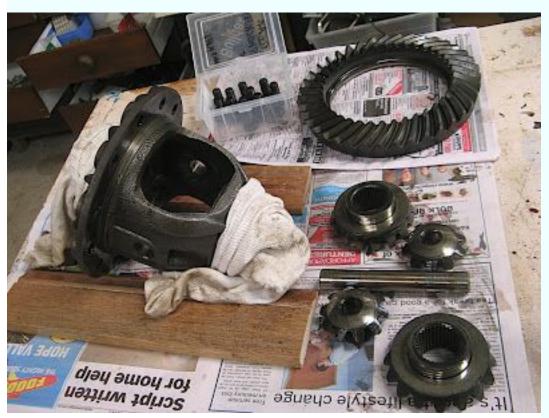
The diff in pieces ready for reassembly.

I smoothed the rusted and pitted surfaces of the ring gear with fine emery paper and WD40 and cleaned them off with Brake Cleaner fluid.

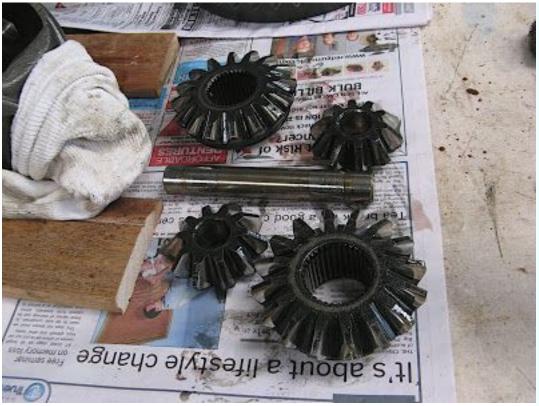
The Differential Gear Set.

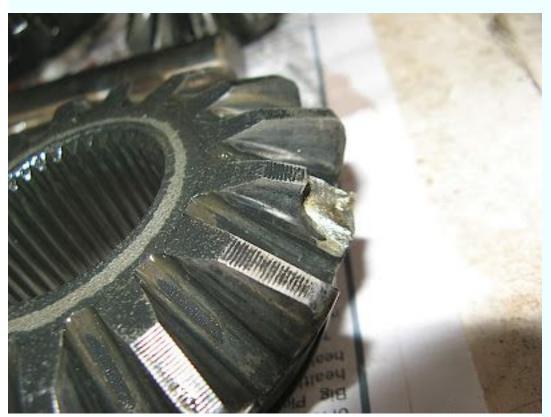
The broken gear wheel will end up in my Museum of Broken Car Parts which is becoming quite extensive.

A close up of the offending tooth.

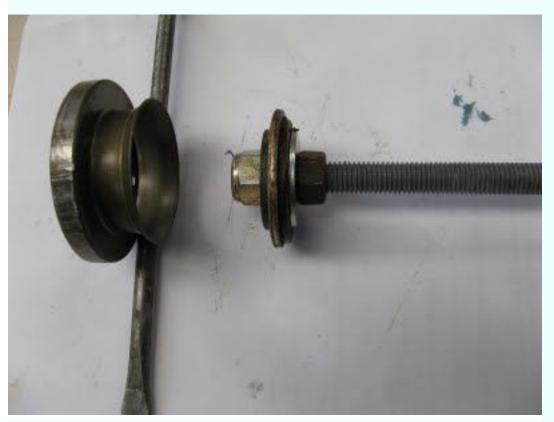
The pusher for removing the inner seals and cleaning out the axle tubes.

To remove the inner diff oil seals I built a pusher rod made of a metre of 12mm tapped rod with a large steel washer, just the diameter of the rear guide section of the seal, bolted to the other end. A few whacks with a heavy hammer and the seals popped out into the diff chamber. Other people have used a large socket and several extension bars to achieve the same result, but I didn't have the right size socket (or sufficient extension bars). The bar needs to be at least 1 metre long to remove the LHS seal.

This bar, with a sock tied over the washer, also makes a useful tool for cleaning out the oily/muddy sludge from the axle tubes.

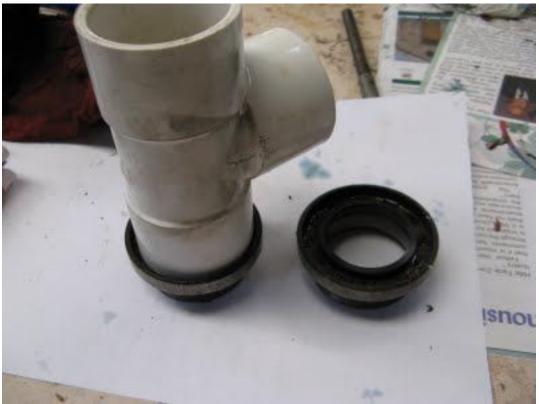
A modified 40 mm high pressure water fitting would fit inside the body of the seal.

To insert the seals I used a modified 40 mm high pressure water

fitting, which just fits inside the seal body, to avoid damaging the plastic parts of the seal with a hammer. The fitting will need to be cut down to about 50 mm long to allow a hammer to be swung inside the diff housing. I drilled and fitted a long bolt to the side of the plastic fitting as a handle, to keep my thumbs well clear of the hammer. A suitable socket might also work. Alternatively a pusher tool could be made up as described in the Dana 60 manual. Any rust or corrosion around the seal location should first be removed and the surfaces smoothed down.

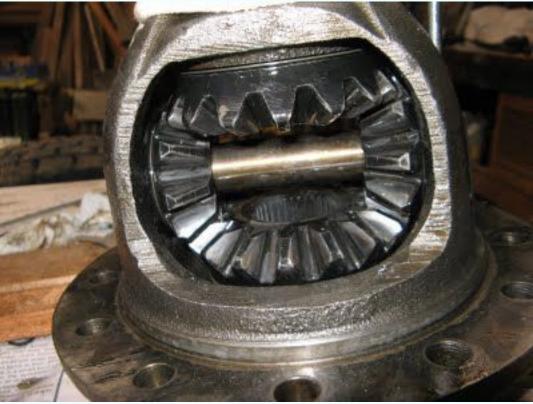
Gears reinstalled in the carrier.

You'll need about 15 fingers to hold the 4 gears and their thrust washers in the right place but it's not too difficult. Insert the side gears first on their washers, with the carrier horizontal so they can't fall out. Then insert both spider gears exactly 180° apart from either side of the carrier and walk them into the carrier case by turning both side gears in the same direction. If they are not exactly 180° apart on the side gears the cross shaft holes won't line up. I found it easier to

slide the saucer shaped thrust washers in behind the spider gears after the gears were in place.

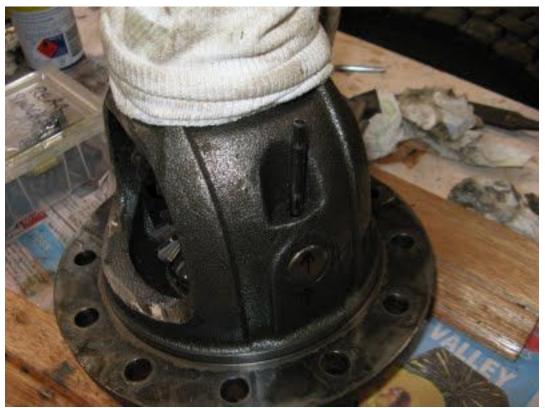
Driving the Roll Pin home to complete the assembly.

Once all the gears are in place, centre the the spider gear washers with a finger and insert the cross shaft with the roll pin holes roughly in line. Use a thin bar to turn the cross shaft until the roll pin holes line up and drive in the roll pin. The differential gears are now complete, assuming they all turn smoothly.

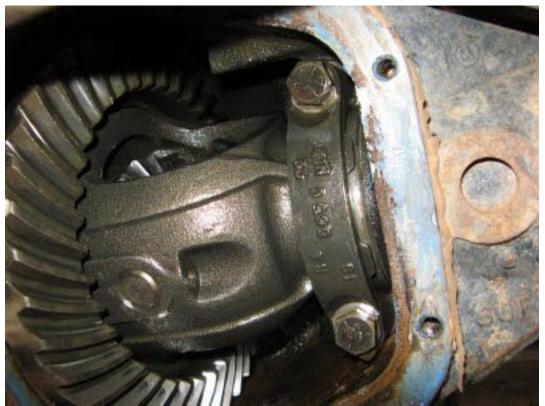
The bearing cups had previously been rotating in their housing and caused a burn mark so I applied some Loctite 641 (bearing retaining compound) to the housing and bearing caps to stop them rotating.

The differential installed in the carrier.

It took me a couple of goes before I could locate the carrier properly, but I had the bolts and bearing caps ready to go so that when finally it slipped into place I could whip in a bolt to hold it there before it all fell out again. Had the diff carrier been a press fit requiring a diff spreader to remove it, I doubt that it could have been replaced in situ and the axle would have had to be removed first.

Once I had recovered my strength and confirmed that the gears all rotated correctly, I Loctited the bearing cap bolts and torqued them up to 80 ft-lbs. The bearing caps should be replaced in the same orientation as previously. They have stamped markings on to aid identification.

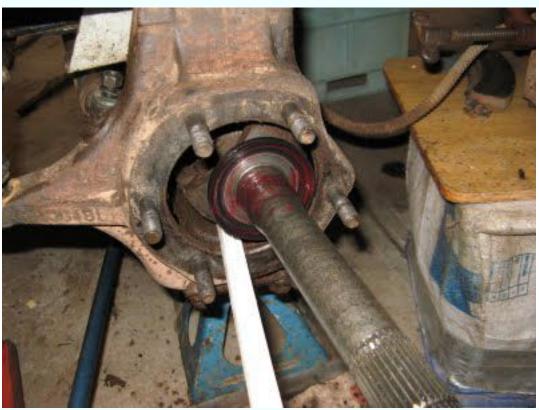
Using a length of plastic strip to keep the drive shaft out of the dirt. The oil seal has also been replaced.

When reinstalling the drive shafts I wanted to avoid the splined end from collecting dirt, as it was pushed along the axle tube, and injecting it into the diff housing. So I placed a thin plastic strip in the axle tube and slid the drive shaft along that and straight into the diff. The plastic strip was actually the cap from a length of Clipsal rectangular electrical conduit and acted like a thin "V" shape for the splined shaft to slide along. When the shaft had entered the diff housing but not fully engaged with the side gear, I pulled the plastic strip out of the axle tube and pushed the drive shaft home, all nice and clean.

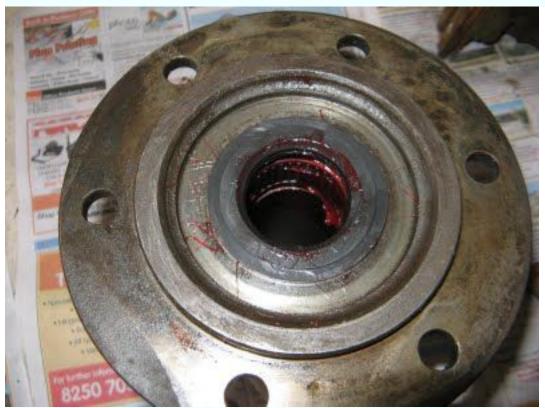
Needle bearings greased and new oil seal fitted into spindle.

Before refitting the spindles, I levered out the old oil seals (which had broken in 2 anyway), flushed out and re-greased the needle bearings and tapped new oil seals into the back of the spindles.

Clean and grease the rear of the spindles around the needle bearing seal since the drive shaft oil seal engages that surface.

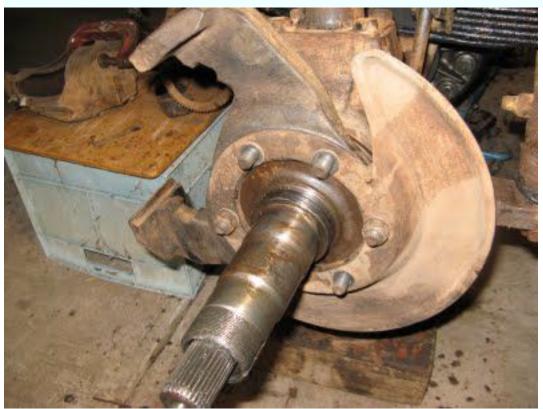
Refitting the Spindle, drivers side.

Wrong. There are pictures of the axle, spindle and hub arrangements and pictures of the brake rotor and calliper, but none showing both. Eventually I deduced that the spindle is attached direct to the steering knuckle with the brake calliper plate on next and the stone guard on last. It didn't look right, due to the cranked angle of the calliper plate and stone guard, but it was logical when I thought about it.

Loctite the spindle fixing nuts and tighten them to 65 ft-lbs. Once the hub is in place you can't reach them anymore.
